# Studying the cracking system in 17-18th century Portuguese Azulejos with SEM

João Manuel Mimoso, LNEC, Lisbon, Portugal, [jmimoso@lnec.pt](mailto:jmimoso@lnec.pt)  
 António Santos Silva, LNEC, Lisbon, Portugal  
 Susana Xavier Coentro, Univ. Nova de Lisboa; LNEC trainee

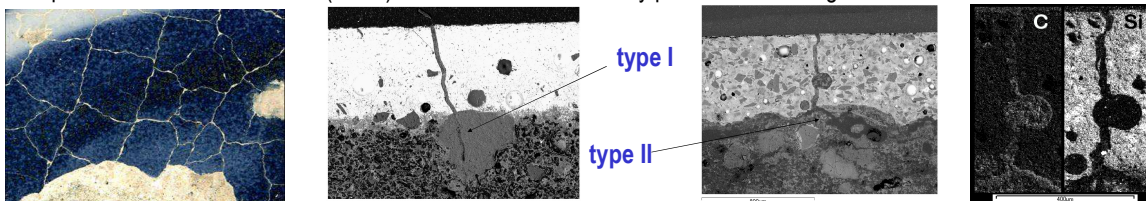
Above left to right- A pattern of crazing highlighted by efflorescence and BSE images of an azulejo cross section showing Type I crazing cracks propagating vertically from the glaze (brighter colour) into the darker clay body (sample Az02/07) and Type II cracks propagating sideways in the glaze-biscuit interface with X-ray maps of Carbon and Silicon to enhance the paths (sample Az02/06)

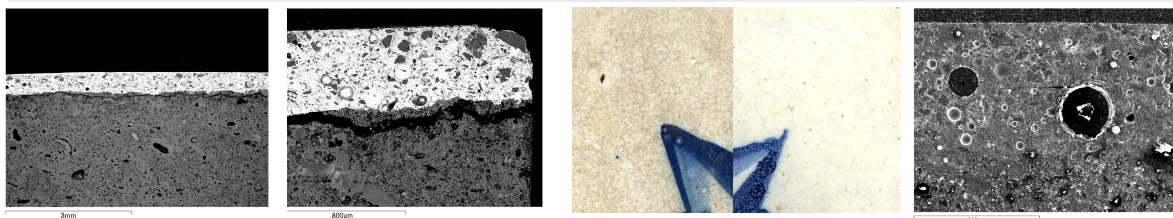
Left side: backscattered SEM images showing a shivered tile with characteristic wavy morphology; Right side: a tile affected by an organic staining of the white majolica compared to a sound tile- staining starts inside the bubbles in the glaze and the BSE image proves that some bubbles are accessible from the surface (these are filled with resin and clearly distinguished (sample Az02/03)
