**A RESEARCH ON MANUFACTURING DEFECTS
AND DECAY BY GLAZE LOSS IN HISTORICAL
PORTUGUESE AZULEJOS**

DEPARTAMENTO DE MATERIAIS
Núcleo de Materiais Pétreos e Cerâmicos
Núcleo de Materiais Metálicos

Lisboa • Janeiro de 2011

RELATÓRIO 24/2011 – NPC/NMM

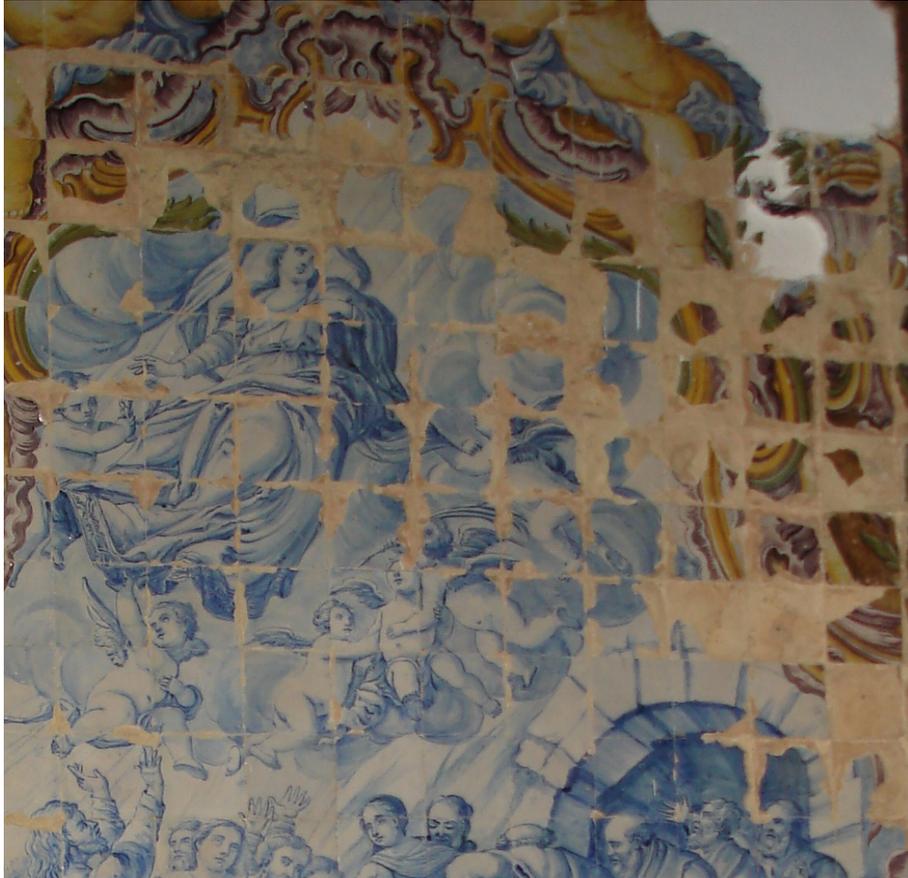
Figure 2 - Azulejos suffer from pathologies resulting in the loss of glaze (Igreja do antigo Mosteiro de Jesus, Setúbal- December 2008)

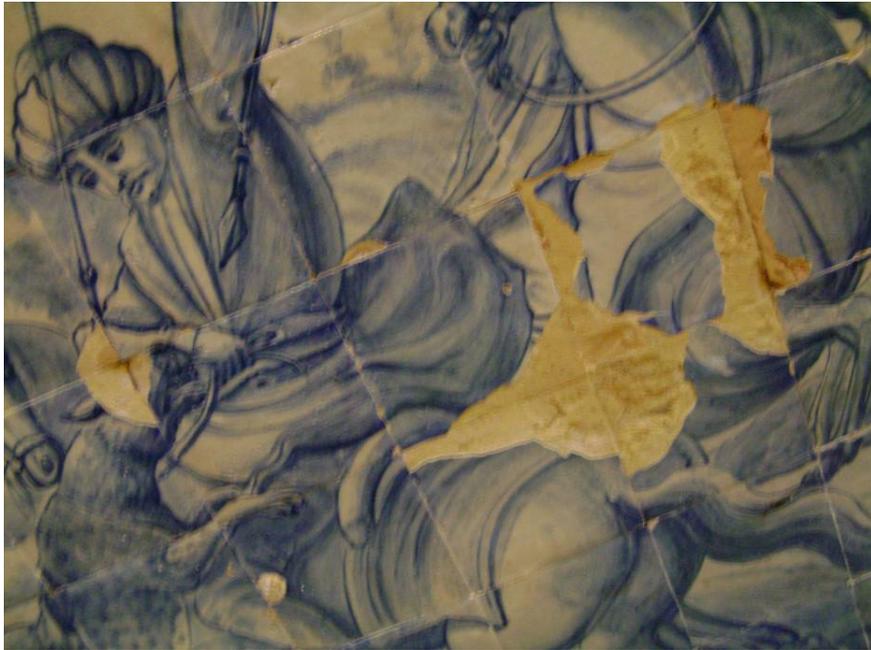
Figure 3- Loss of glaze in a stairs hunt scene of the second half of the 18th century (Palácio do Raio, Braga - February 2009)

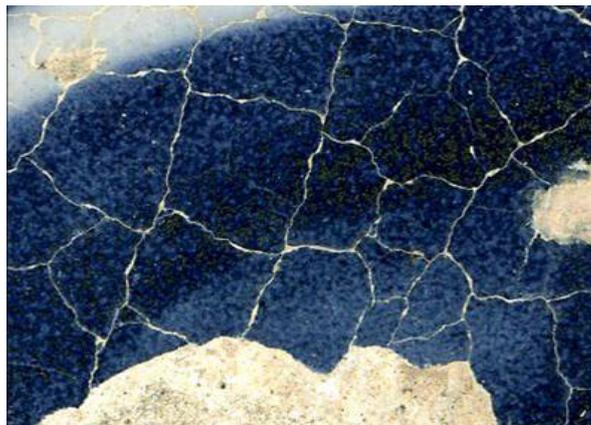
When a tile cools after the second firing and if the thermal expansion coefficients of the glaze and the biscuit are not finely tuned, the glaze top may contract substantially more than the biscuit. Then the ceramic body exerts through the interface a homogeneous traction on the glaze. Glass cannot respond elastically and will crack. The fissures propagate sideways, until a crack meets another at an app 90° angle, and vertically until the tension is relieved [7]. This situation leads to *crazing*, the formation of a cracking pattern in the glaze resembling drying mud and often referred by the French designation *craquelé*. Visually, the pattern seems formed by odd trapezoidal polygons with similar dimensions (figure 7).

Figure 7- A pattern of crazing highlighted by efflorescence

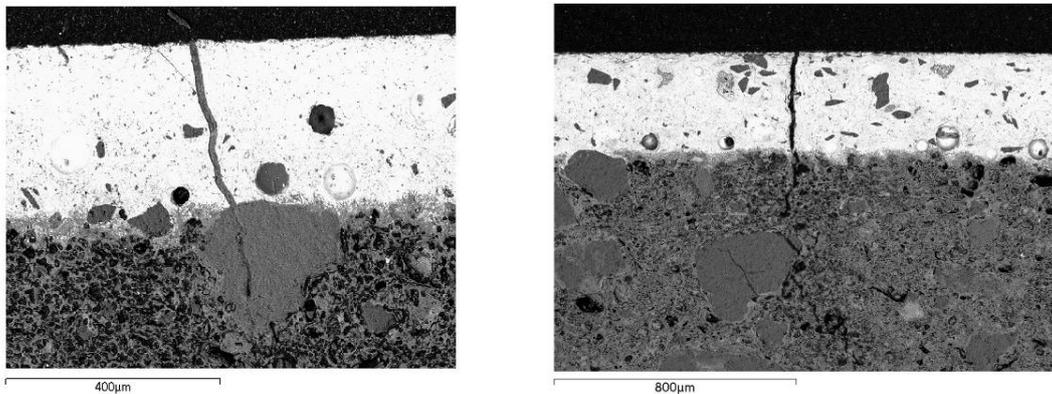
Figure 8 shows the path of vertical propagation of individual crazing cracks in one of our samples. This is the simplest case, where cracks propagate down for a length that does not usually exceed double the glaze width, without branching. We named these: *Type I* crazing cracks.

Figure 8- BSE images of an azulejo cross section showing crazing cracks propagating vertically into the ceramic body (sample Az02/07)

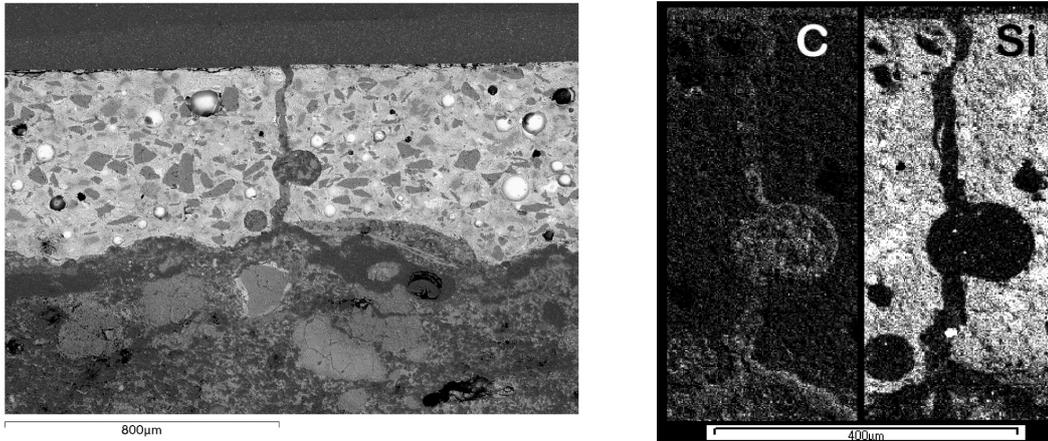
Figure 9a shows crazing in a case where the cracks propagate into the biscuit but mostly in the glaze/biscuit interface (the slide was prepared from a sample of the tile illustrated in figure 7). The SEM images clearly show the vertical development of the crack that distorted a gas bubble, propagating sideways under the glaze. Using the fact that the impregnation with resin filled the accessible voids, figure 9b depicts an X-ray map of Carbon, marking positively the path into the biscuit, and figure 9c a similar map of Silicon, which is a negative marker of voids and often shows the cracking patterns in a more clear way. We named these: *Type II* crazing cracks.

Figure 9a- BSE view of a crazing crack propagating in the glaze/biscuit interface and close-up X-ray maps of Carbon (9b) and Silicon (9c)- sample Az02/06

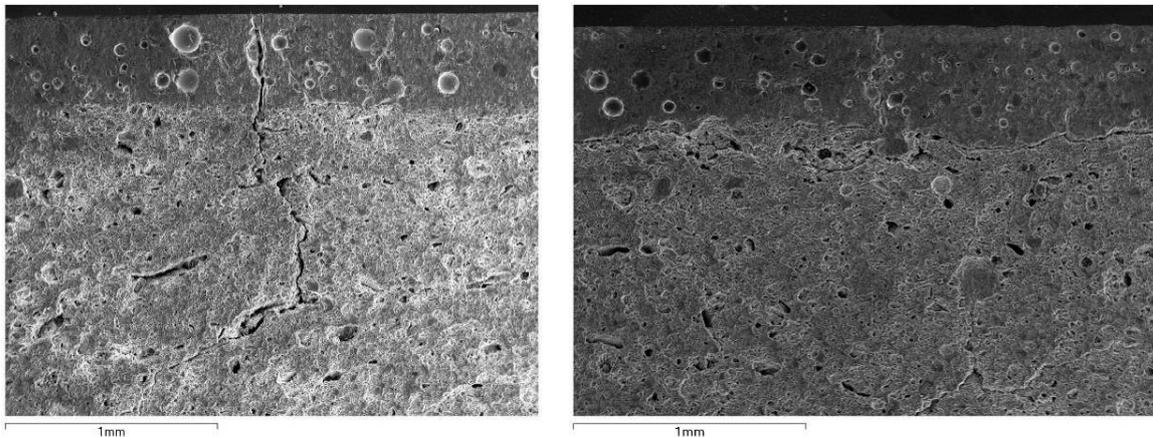
Not all tiles craze down, either into the biscuit, or else sideways under the glaze. In some, both paths offer routes of similar resistance and thus cracks propagate both down and sideways. Figure 10 illustrates two views taken on a single tile illustrating the double path.

Figure 10 – SEI images of sample Az02/11 showing crazing cracks propagating down into the biscuit with side branching (9a) and sideways into the glaze/biscuit interface (9b)

actually spanned its whole width at some spots and was widely colonized by filamentous fungi. The cases of mixed propagation like this one must be considered as Type II crazing because, as shall be shown next, that is the type resulting in a more immediate risk to the preservation of the tile.

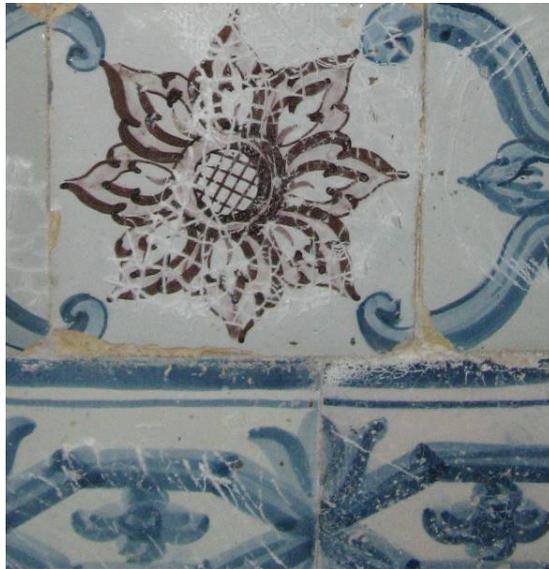
Whenever salt crystallization occurred on the sites we visited, two cases were recognized which correspond to the two kinds of crazing. The Type I “vertical crazing” as illustrated by figure 8 offers a direct route from the biscuit outwards which, when the cracks are open and soluble salts are present, results in a pattern of efflorescence highlighting the glaze cracks (figure 11). Several similar cases were seen and, whenever possible, documented with the same outcome: although efflorescence confirms the evaporation of moisture from the walls, there was no actual decay in terms of macroscopically recognizable glaze loss directly attributable to the crazing. In figure 11 some areas of glaze loss are clearly visible but they pertain mostly to the edge areas where crazing is not even apparent.

Figure 11- Efflorescence in a crazed tile
(Coimbra Old University- photographed 2008)

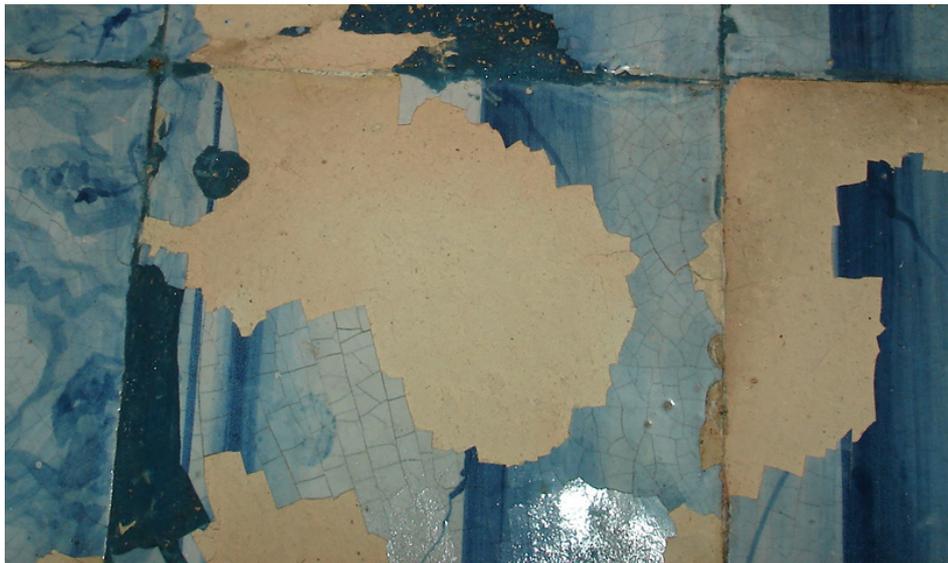
Type II crazing that propagates horizontally is a different matter altogether. Since it runs into the glaze-biscuit interface, it causes a partial delamination of the mosaic patches of glaze. And so Type II crazing as illustrated in figure 9 originates a mosaic of “glaze islands” that are already partly detached from the biscuit. The hidden crystallization of salts or any other physical process causing shear stresses in the interface (moisture or thermal cycles, or maybe even vibration) may conceivably contribute to the propagation of damage resulting in a patchy mosaic-like detachment (figure 12). In this form of decay, a clean relatively smooth biscuit surface results with a characteristic polyhedral glaze boundary resulting from the detachment of full crazing “islands” or parts thereof. Often this sort of crazing is also highlighted by efflorescence, particularly whenever the loss of glaze is yet minimal, but it will likely, in time, lead to glaze detachments and thus calls for remedial measures without which all the glaze may eventually be lost.

Figure 12- Delamination of the glaze from the biscuit in a severe case of Type II crazing (Igreja dos Terceiros de S. Francisco, Viseu- May 2010)

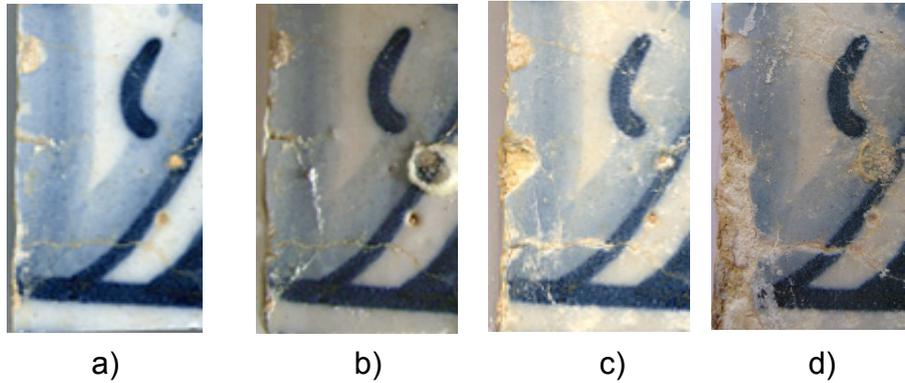
detachment of one of the glaze mosaics at cycle #3 in a sample cut from the tile illustrated in figure 7 (see figure 13), with new detachments starting to be apparent at cycle #4.

Figure 13- Delamination of the crazed glaze from the biscuit after cycles of accelerated ageing with sodium chloride solutions, as described in Chapter 2.3. a) before the saline solution imbibitions; b) after 1 cycle, c) after 3 cycles, d) after 4 cycles.

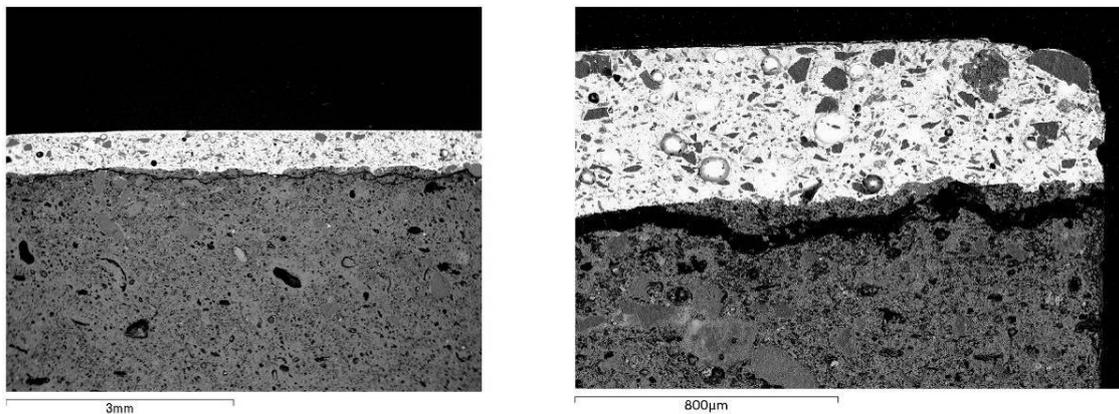
Figure 15 depicts a section across a shivered tile with delaminated glaze, showing the wavy crack which results from a dimpled fracture surface, demonstrating that it propagates through the biscuit, only occasionally touching the glaze. This means that in the typical shivered tile, the glaze will fall off with adherent biscuit, forming dimples that are clearly seen and felt, while a clean detached glaze may point to a different problem (lack of glaze/biscuit adhesion with or without concomitant shivering).

Figure 15- SEM (BSE) images showing the glaze delaminated by shivering depicting the characteristic wavy morphology corresponding to the sectioning of a dimpled shear fracture and its propagation almost exclusively through the ceramic body

Figure 15 illustrates a case where the delamination goes right to the edge of the glaze. In this case, any moisture with dissolved salts would evaporate near the exit and crystallization would commence near the edge and “lift” the glaze from there. The glaze loss would typically progress from the edges, and this is likely the cause of a typical morphology of decay in which the glaze loss progresses towards the centre of tiles, often with a pattern of cracking of the remaining glaze that follows the border of the lost area (which we call a *delamination front*) and marks the next pieces of glaze that will fall down. Figure 16 illustrates the typical morphology of a panel decaying in such a way, whose tiles were probably more or less delaminated to the edges as a consequence of a faulty manufacture.

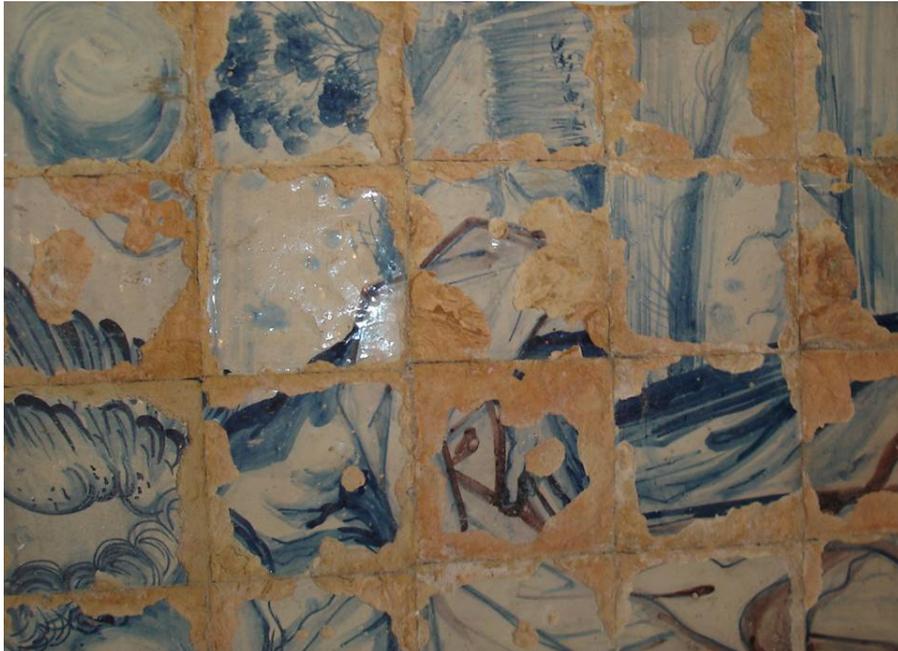
Figure 16 – A typical decay morphology probably indicating that the tiles were initially shivered to the edges (Viseu Cathedral- May 2010)

Examining figure 16 more closely, half a dozen spots will be noticed in which the glaze loss does not actually go to the edge, but rather makes up a round lacuna somewhere inside the glaze. The situation is exemplified by the tile in figure 17.

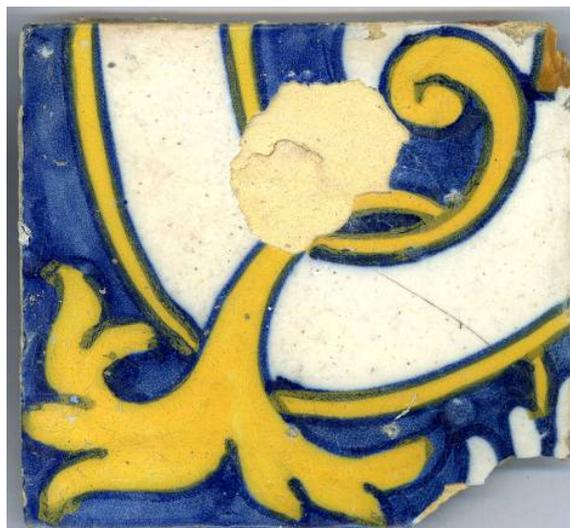
Figure 17- 17th century tile with a round lacuna inside the glaze area

This case corresponds to shivering delaminations which only affect an area inside the glaze and do not go to the edge, as exemplified by the longitudinal cut of figure 18. It is an important cause of decay, as will be seen next.

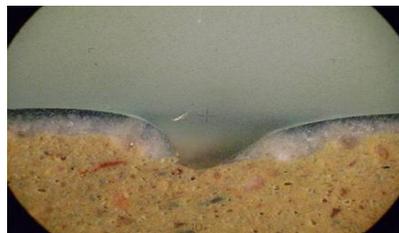
When the glaze has pin-holes (figure 19) these provide an evaporative route to the water wetting the ceramic body. If that water contains soluble salts, as it in general does, crystallization will occur under the pin-hole, in the empty space between the biscuit and the glaze. The agglomeration of salt will eventually start lifting the glaze, forming a bubble that, in time, breaks resulting in an immediate roundish lacuna that may have an area exceeding 1 sq.cm. Whenever delaminated glaze remains at its boundaries, the process will proceed and the lacuna will slowly widen until most of the glaze is lost (figure 20a, b).

Figure 19- A pin-hole through the glaze provides a direct evaporation route from the ceramic body to the exterior

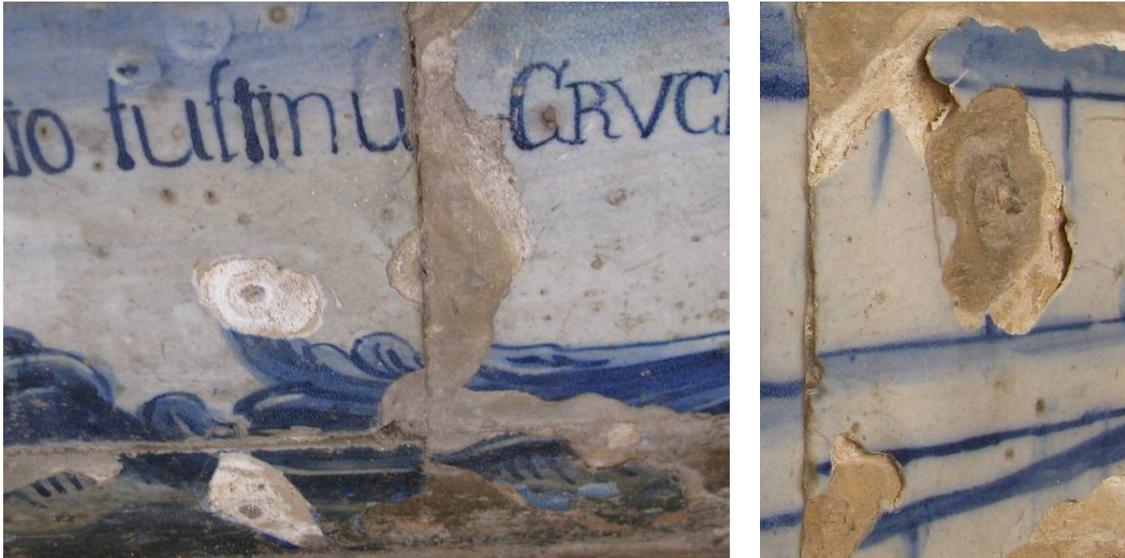
As said before, such cases need the previous occurrence of shivering delamination and a pin-hole through the glaze. After the lacuna is formed, the imprint of the original pin-hole can sometimes be recognized on the remaining biscuit, often with rings of salt crystallization around it, giving testimony of the process that lead to it (see, for instance, figure 20 a).

Figure 20a- Typical glaze loss through efflorescence under a shivering delamination (the position of the evaporation pin-hole is imprinted on the ceramic body) and (20b) grazing view of another area of the same panel making the delamination apparent (Madre de Deus Convent, Lisbon- July 2009)

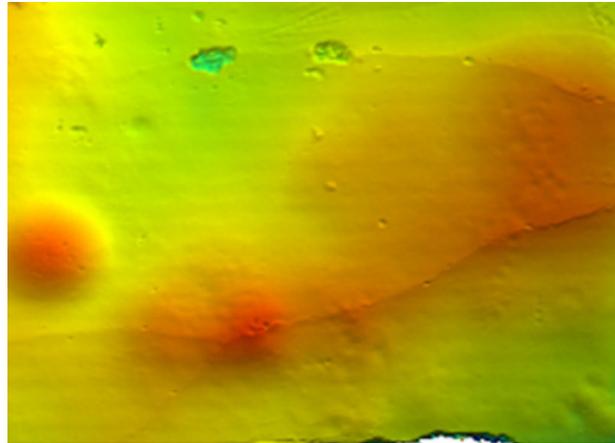
Figure 21- 3D optical surface profile of a sample of the late 17th century tile of figure 18 after two cycles of accelerated ageing as described in Chapter 2.3. The raised area of delaminated glaze and its breakage are evident.

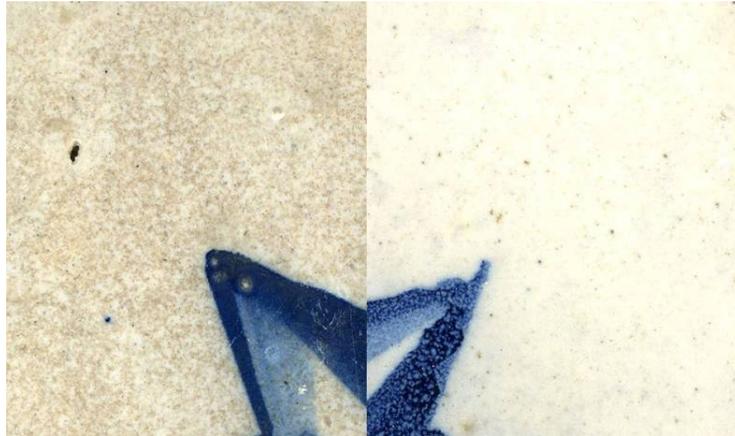
Figure 24- A tile affected with a pathology that stains the white majolica compared to a sound tile

The fact that some tiles in a panel are affected by this pathology while others seem immune to it (as happens, for instance, at Palacio Pimenta in Lisbon, where the kitchen azulejo cover shows a chequered pattern of stained and sound tiles) and noticing that it affects most often azulejos of cheaper production and a more recent manufacture (late 18th and 19th centuries) lead to the notion that it too derived from some manufacturing defect that made the glaze more

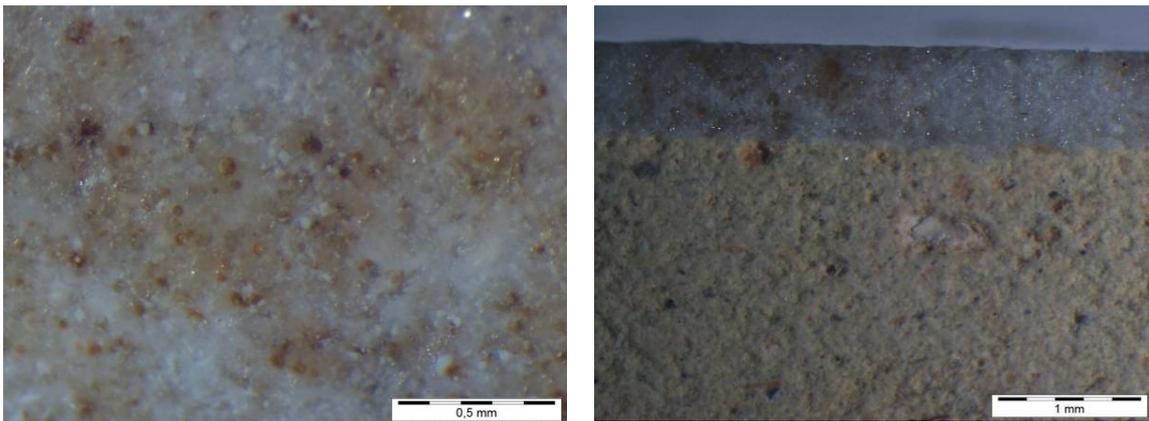
Figure 25 – Microscopic images of a stained tile seen from the top (25a) and in section (25b)

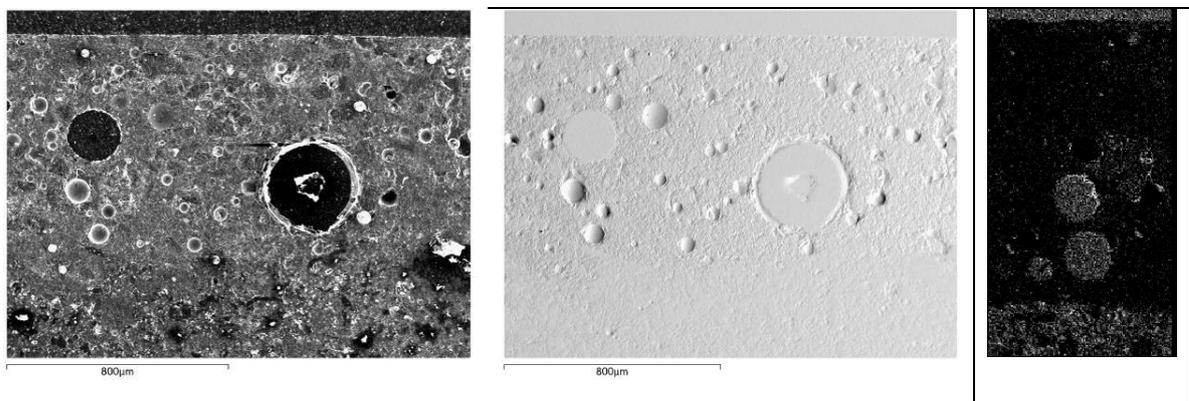
A simple check was performed on samples prepared for SEM work that were purposely not re-impregnated after cutting. Then, any bubbles filled with resin have to have been filled from the exterior, even if the entry path is not evident in the final section used for viewing. Figure 26a depicts an example in secondary electrons imaging (SEI) in which the resin-filled bubbles are conspicuously black. Figure 26b shows the same in the so-called topographic mode (BSE-TOP), in which those resin-filled bubbles come out flat contrarily to those that are not connected to the glaze surface and show as caps. Finally figure 26c depicts the X-ray map of Carbon in another area of the same slide in which three bubbles near the glaze/biscuit interface are seen to be filled with resin and thus prove to be connected to the surface of the tile.

Figure 26- Those bubbles accessible from the surface (and potentially stained with a brownish inclusion) can demonstrably be filled from the surface with impregnating resin and clearly distinguished in SEI (left), BSE-TOP mode (center) and in an X-ray map of Carbon of another area of Sample Az02/03
