Inglesinhos convent: Compatible renders and other measures to mitigate water capillary rising problems

Journal of Building Appraisal (2009) 5, 171–185. doi:10.1057/jba.2009.28

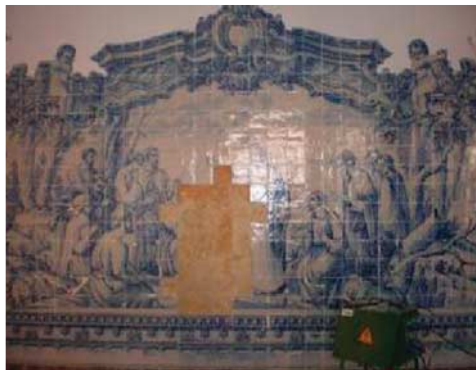
Figure 3: Lacuna in the interior glazed tiles ('azulejos') showing the old lime plaster.

The building plan is composed of rectangles and is organized into large circulation and distribution corridors; the ground floor roof is executed in groined vaults. The old renders and plasters were based on lime mortars, with a pinkish coloration, as it was possible to observe in a lacuna existent in the entrance hall wall cover, constituted by beautiful ancient glazed tiles ('azulejos') (Figure 3).

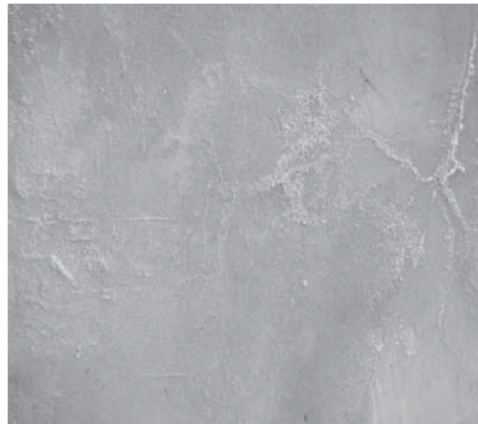
Several anomalies appeared after application of the new renders and plasters: dark moisture stains, salt efflorescences, loss of cohesion of the paint, blisterings and detachment of the paint (Figures 4–6).

Figure 4: Efflorescences in the rendering cracks.

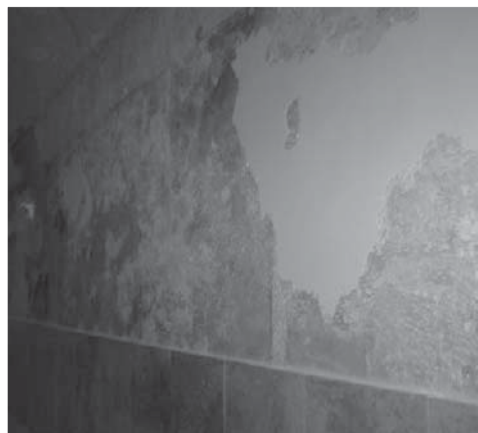
Figure 5: Detachments (large lacuna) of internal finishing.

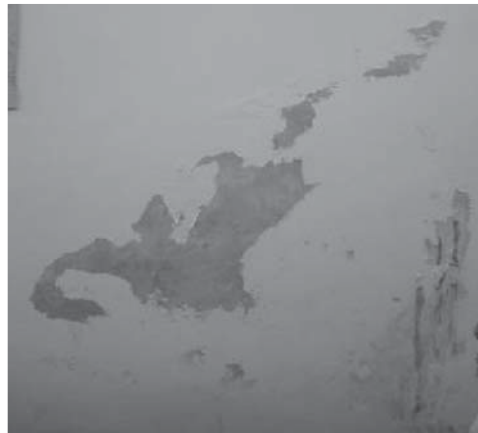
Figure 6: Detachment of the render painting.

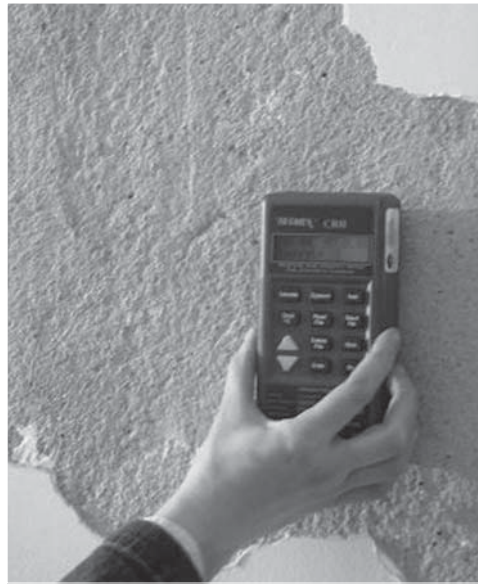
The portable humidimeter (Figure 9) – Tramex CRH – is a device used to evaluate water content in walls (Henriques, 2001; Massari and Massari, 1993; and Veiga *et al*, 2009). This test was performed in several internal and external walls, at different heights – 0.30 m and 1.80 m from the pavement – and in two different conditions – dry weather and after a rainy week – in order to determine the possible origin of the water. The results of these measurements are summarized in Tables 1 and 2.

The comparative analyses of the results reported that the walls of the ground floor experienced higher humidity than those of the higher floors. The interior walls were found to have high moisture contents, almost as high as those of the external walls. This moisture increased after rainy periods. In the interior walls and some exterior walls, the humidity content was higher at the base, decreasing towards the top of the walls. High moisture contents were concentrated at the base of the vaults and in other places, especially near the windows and under the cornice. These results showed that the main water source is not infiltration by exterior walls, and that there is capillary rising water

Figure 9: Evaluation of the moisture content with portable humidimeter.

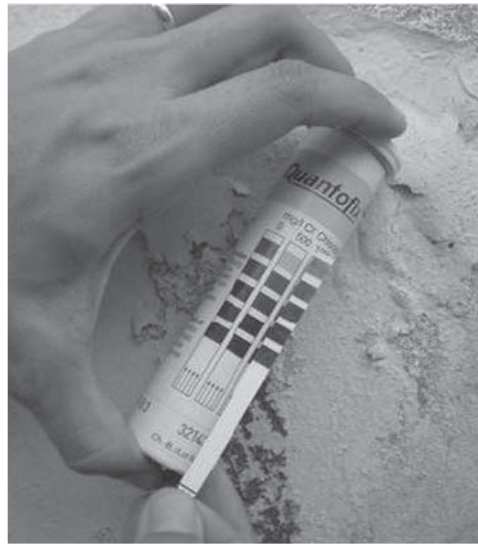
With the strip tests (Figure 10), information on the type of salts present was obtained, as well as information on the degree of contamination, based on semi-quantitative determination of the ions associated with the type of salt (Borrelli, 1999 and Veiga *et al*, 2009). The results of these measurements are summarized in Table 3.

The salts present were found to be mainly sulphates (large content in one of the interior walls) and chlorides, but some nitrates were also detected. Their presence was probably due to the interaction of contaminated water from the ground, to the presence of cement in the mortars and to the existence of salts in other wall materials or in the ground. Salts can be transported in a porous material only if dissolved in water (Lubelli *et al*, 2006), and thus their presence indicates water transport through the walls. Despite the lower dissolution rate of sulphates, when compared with the other salts present, the circulation of water in the walls can promote their dissolution and dissemination (Ottosen *et al*, 2008).

Figure 10: Strip tests – semi-quantitative determination of salts.

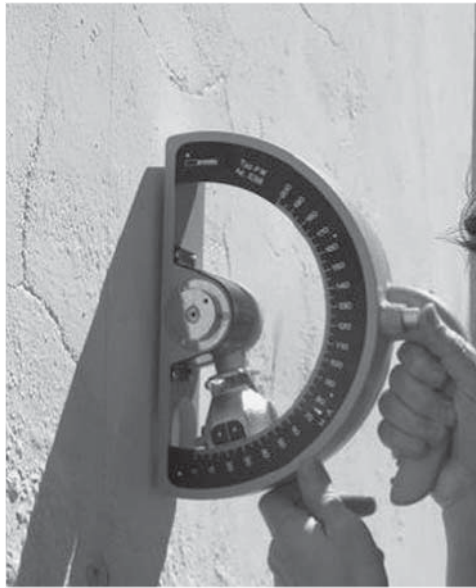
The tests with the pendular Schmidt impact hammer (Figure 11) – Schmidt PM – and those with the Durometer Shore A (Tavares and Veiga, 2007) (Figure 12) based on ASTM D22240, were performed to assess the strength of the superficial layers of renders, in order to verify how the moisture content affected the mortars' cohesion. The results are summarized in Tables 4 and 5.

The tests showed the reduction in mechanical strength and cohesion of the degraded renders, by comparison with measurements performed on experimental panels made *in situ* and with determinations carried out in previous case studies on sound mortars (Tavares *et al*, 2008). The tests with the pendular Schmidt hammer were more expressive than those with the Durometer, which affects more superficial layers.

Figure 11: Pendular Schmidt impact hammer test.

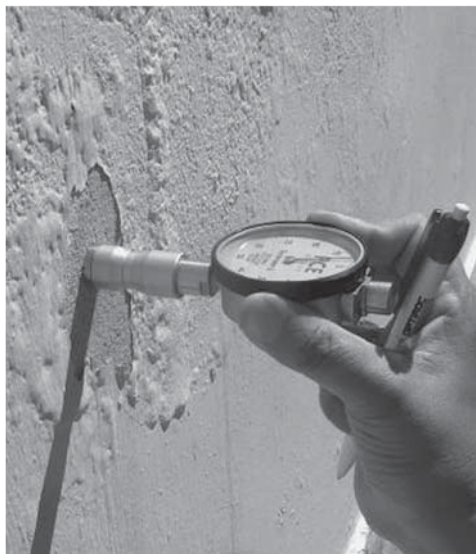
Figure 12: Durometer test.

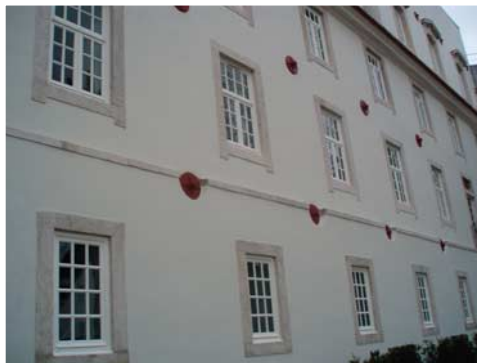
Figure 20: General view of the final appearance of the East Façade finishing.

The construction company, Edifer Construções, cooperated in the various stages of the study and implemented the recommended measures, despite the difficulties involved. The final aesthetic appearance of the building was close to that of the original, preserving the identity of the historic building (Figure 20). The collaboration of all intervenients in the process was crucial in achieving the elimination of anomalies with the minimum cost and delay of the works, and in promoting the success of the intervention at aesthetic and functional levels, according to the ethical principles of conservation.
