MECHANICAL CHARACTERIZATION OF TRADITIONAL TIMBER CONNECTIONS: EXPERIMENTAL RESULTS

E. Poletti ¹, G. Vasconcelos ², J. M. Branco ², A. M. Koukouviki ³

² ISE, Department of Civil Engineering, University of Minho, Portugal

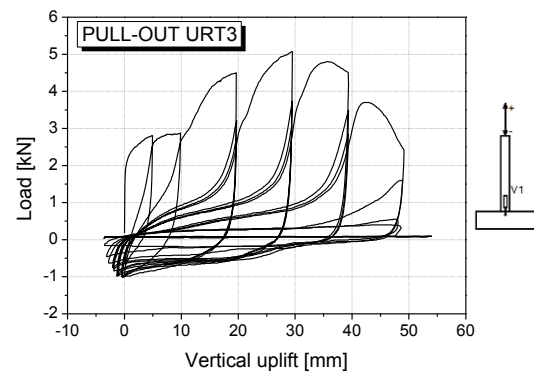
Fig. 6 presents a typical force-displacement diagram characterizing the pull out response of the connection. The diagram is characterized by a high initial stiffness and an early non-linear behaviour. In the unloading branch, the connection has an immediate loss of strength and then acquires compression forces. This is associated to the reaction to the re-entering

Fig. 6 – Typical pull-out cyclic test result on unreinforced connection.

of the post to its original position in the beam, due to the plastic deformation developed in the nail.

On the other hand, the reloading branches present a high amount of pinching, caused by the crushing of the wood surrounding the nail and consequent increasing clearances. Important strength degradation is observed during the tests. This phenomenon is not only observed between two successive steps, but also in the stabilization cycles. These two characteristics (pinching and strength degradation) were observed in the cyclic behaviour of timber frame walls without infill, as the behaviour of the connections affects the response of the wall.

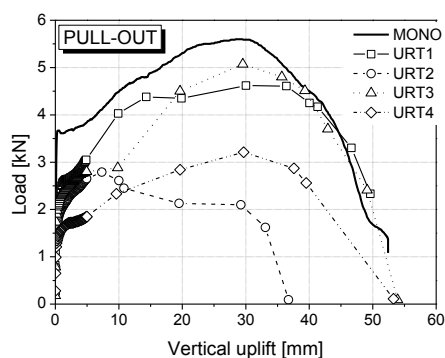
Even though the general behaviour of the specimens was similar, it was noticed that the maximum load and stiffness of the joint depends greatly on its level of interlocking. For high clearances present in the joint, its load capacity decreased and the out-of-plane opening of the post progressed more rapidly. Comparing the envelope curves of the specimens (Fig. 7), specimen URT3 reached a maximum load of 5.07 kN, whereas URT2 only reached 2.79 kN, meaning that the resistance decreased by 45%. Moreover, the two specimens with the higher clearances (URT2 and URT4) failed earlier, since the nail pulled out of the beam completely.

Fig. 7 – Envelope curves for all specimens.

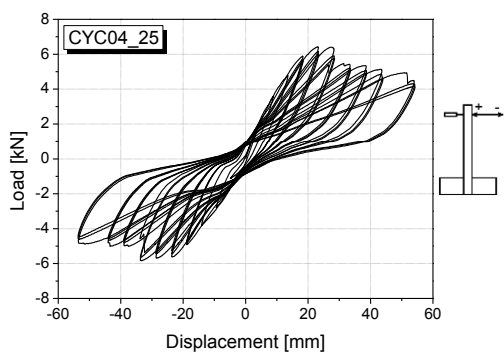
Fig. 8 presents a typical hysteretic curve for the lower pre-compression level. The connection has a linear initial response and non-linearity appears nearer to the maximum load capacity. Strength and stiffness degradation was observed. From the comparison of the envelope curves of all tests performed (Fig. 9), differences in the response regarding mainly the maximum load capacity were attributed to the quality of the joint and of the material, as the presence of knots or of grain misalignment led to lower values of load.

Fig. 8 – Typical pull-out cyclic test result on unreinforced connection.

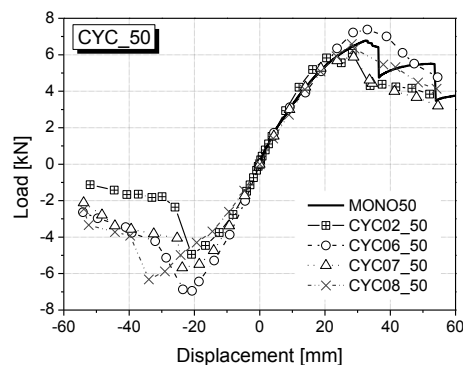
For the lower vertical load level, the average maximum load is 5.53 kN while the minimum -6.61 kN, with variations of 19%. For the higher vertical load, the variation was lower, with an average maximum load of 6.48 kN and a minimum of -5.98 kN and a variation of 10% and 14% respectively.

Fig. 9 – Envelope curves for all specimens.

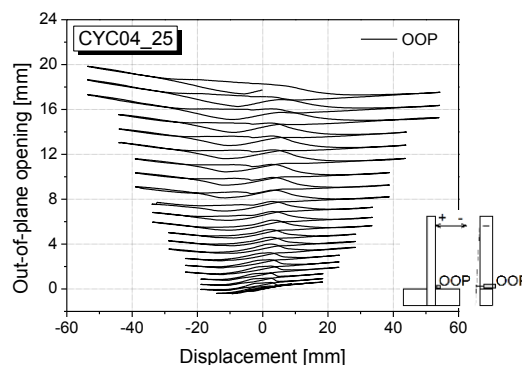
The out-of-plane opening of the connection varied among the tests depending on the level of interlocking. However, the rate of opening was similar. In Fig. 10, where the progressive opening of the connection versus the top horizontal displacement is shown, it is seen that the increase in the connection opening is almost linear and the opening becomes significant only for displacement levels higher than the yield displacement (19.9 mm).

Fig. 10 – Progressive opening of joint.

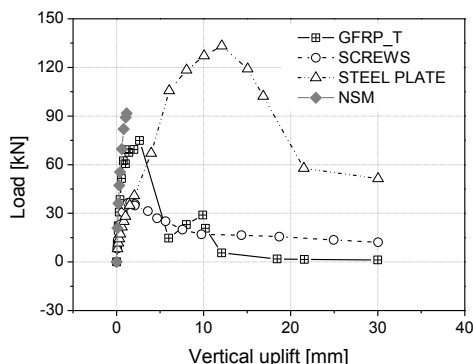
Retrofitting performed with GFRP sheets had a very high initial stiffness and reached its maximum capacity for a low value of vertical uplift (Fig. 11). The diagram presents two peak values, corresponding to the failure of the GFRP sheet first on one side of the connection and then on the opposite side. The strength achieved was 15 times greater than that of the unreinforced specimen. After failure, the strength of the connection was lower than the one obtained for the unreinforced specimen, indicating that this solution is viable only if the maximum strength of the connection is not reached, since its post-peak behaviour is not performing.

Fig. 11 – Envelope curves for retrofitted specimens.

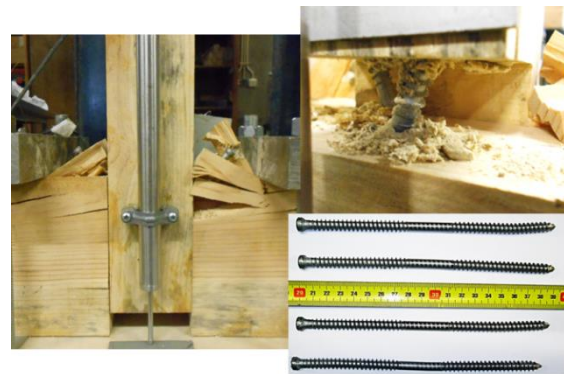
Strengthening executed with self-tapping screws was the less invasive on the connection, being able to greatly improve its strength (6 times over) and stiffness without showing a brittle failure, but actually being able to ensure a post-peak softening behaviour and therefore a great capacity to dissipate energy. For this retrofitting solution, failure was mild, since the damage was progressing throughout the test, with pulling out of the screws, causing slight damages to the beam (Fig. 12). After the peak load the screws were responsible of grain disorganization, which eventually became wood dust. Moreover, at the end of the test, plastic deformations of the screws were observed. Notice that this test is characterized by severe pinching, typical of dowel-type connections.

Fig. 12 – Failures observed for specimen retrofitted with self-tapping screws.

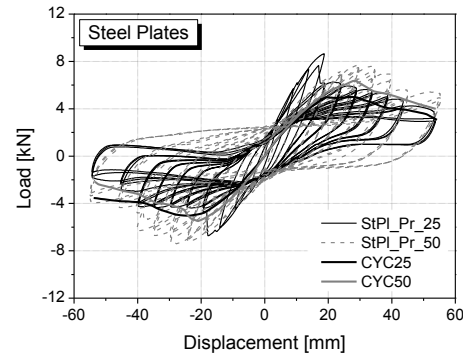
In case of retrofitting with steel plates submitted to lowest pre-compression an increase of 40% was observed for the maximum load (Fig. 13). When the prosthesis failed the upper part of the post was simply rocking. However, for the higher level of pre-compression, this trend was not observed. In this case the post bended and deformations related to buckling were also observed

Fig. 13 – Hysteretic diagrams of specimens retrofitted with steel plates.

in the steel plate. Moreover, cracks opened laterally on the post, similarly to what happened in the unreinforced tests, but the steel plate was still able to promote a higher dissipative capacity. There was an increase in lateral load of 21% and even stiffness increased, though in a lower degree.

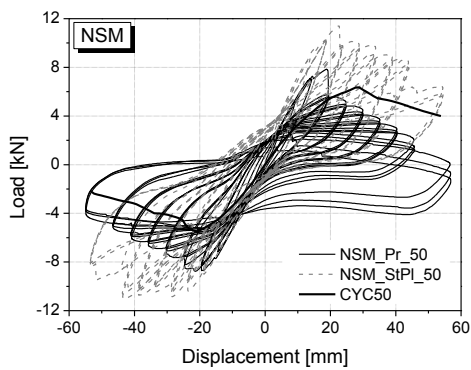
Given this behaviour, it was decided to test the specimens retrofitted with NSM steel rods directly with the higher vertical load. Nevertheless for this kind of strengthening the prosthesis failed even for the higher pre-compression level (Fig. 14). After experiencing an increase in load of 34%, the lower part of the post once again stopped contributing to the resisting mechanism (Fig. 15). This was probably due to the fact that NSM retrofitting stiffens the post more and the high difference in stiffness between the two parts of the post caused the prosthesis to fail even for the higher vertical load.

Fig. 14 – Hysteretic diagrams of specimens retrofitted with NSM rods.

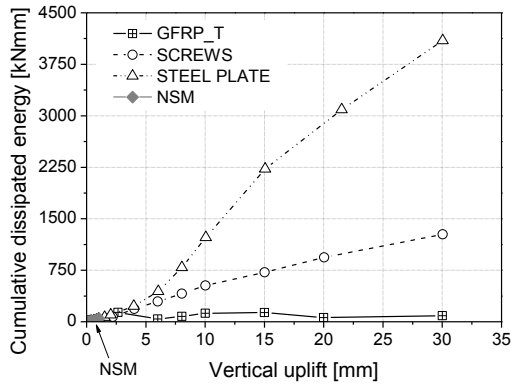
The dissipated energy during pull-out tests carried out on unreinforced specimens was minimal (between 150 and 550 kNmm), especially for connections with an inadequate interlocking, meaning that friction does not play a role in the dissipation of energy. It increases considerably once strengthening against uplifting is applied (Fig. 17). The stiffer solutions highly increased the dissipative capacity of the connections. The more dissipative strengthening technique was the steel plates solution, which increases the energy dissipation by over 8 times. NSM retrofitting gave inconclusive results. Retrofitting with screws was able to promote a good dissipative capacity of the connection, with an increase of 175% in relation to unreinforced specimen. The strengthening with GFRP leads to a good dissipative capacity for low values of uplift, but after failure the energy dissipation is lower than the value found for the equivalent unreinforced connection. Therefore, it is evident that brittle failures should be avoided, since the strengthening becomes inefficient.

Fig. 17 – Cumulative dissipated energy evolution for retrofitted pull-out tests.

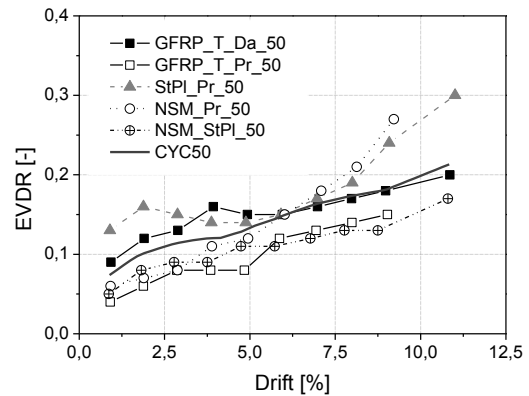
Even retrofitted connections presented peculiar results (Fig. 18), since the rocking

Fig. 18 – EVDR values for retrofitted specimens, in-plane tests.

behaviour of the upper part of the post led to high values of viscous damping. These values, though, are not really representative, since the failure obtained was not that of the connection per se, but of the prosthesis, which should be avoided.
