PARAMETERS AND PROPRIETIES INFLUENCE STUDY IN WEAR BEHAVIOUR OF A CAST STEEL DIN 16MnCr5 HELICAL GEAR

Miguel Mousinho¹, Teresa Morgado^{1,2,3}, David Braga⁴

¹DEMI – Mechanical and Industrial Engineering Department, FCT NOVA - Faculty of Science and Technology, Universidade Nova de Lisboa, Portugal, email: m.mousinho@campus.fct.unl.pt; t.morgado@fct.unl.pt;

⁴SEW-Eurodrive Portugal, Mealhada, Portugal email: dbraga@sew-eurodrive.pt

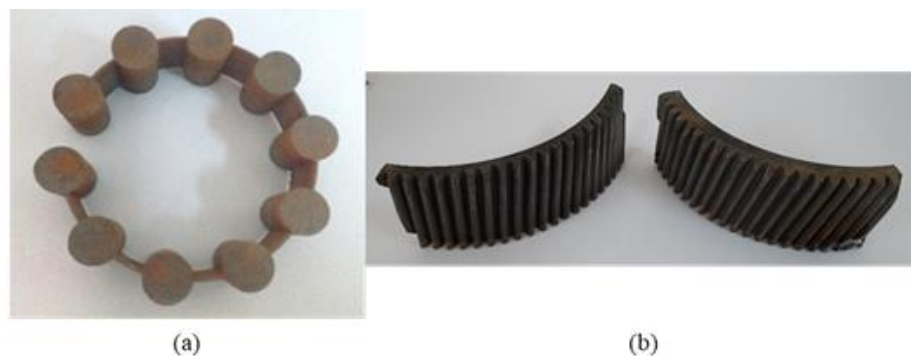
Fig 3 - (a) Samples obtained from the inner part of the helical gear; (b) teeth samples obtained for analysis

It is possible to notice in the figure 3 a) and b) the samples cut from the body of the gear and the two sections of the teeth, respectively.

From the “cylinder crown” presented in fig 3 b), all cylinders were numbered from A to J. Cylinders B and C were a used to make the Vickers micro indentation test in the body of the gear and they were cut in 4 equal pieces of 10mm, making use of an automatic blade (Fig 4).

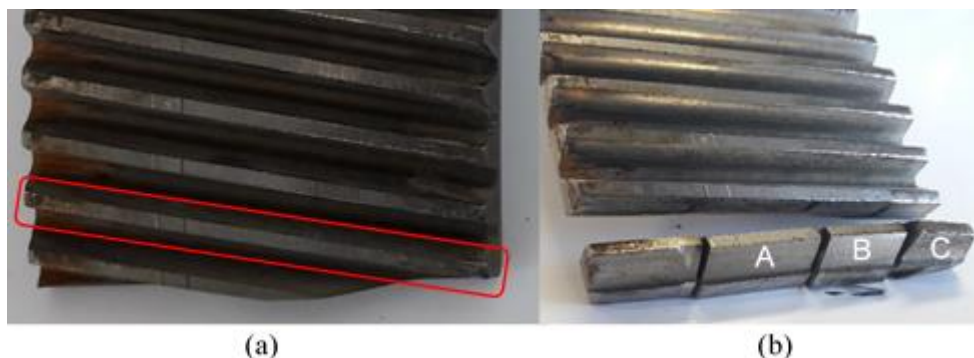
Fig 5 – Specimens cutting for teeth analysis: (a) Section of the gear teeth choose for analysis; (b) teeth A, B and C cut with a grinding wheel

For the gear teeth, a section of one of the samples was cut with a grinding wheel. In the figure 5 it is shown the location of the teeth A, B and C.

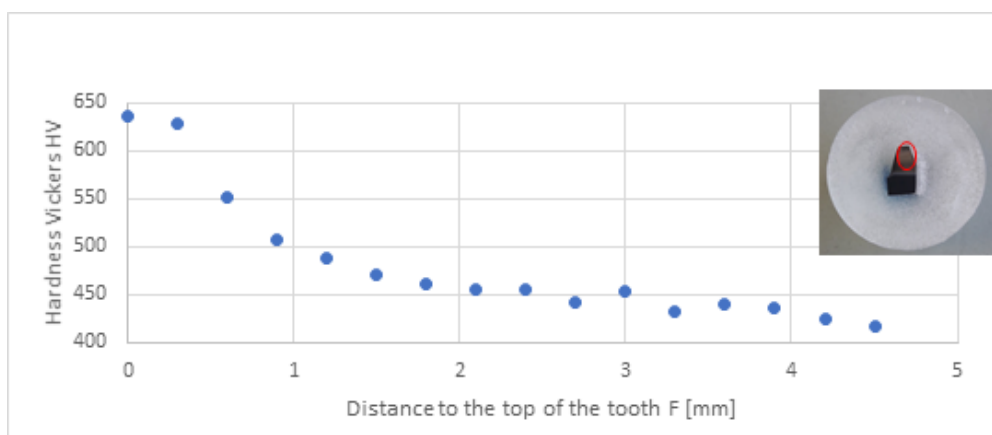
Fig 9 - Variation of the Vickers' hardness in relation to the increase of the distance to the top of the tooth F

The third tests performed aimed to evaluate the variation of the hardness along the profile of the teeth. In figure 9 is shown the graphic of the variation of the hardness in relation the increase of the distance to the top of the teeth F as example. From the analysis made in 6 profiles teeth, it was observed that the micro hardness decrease approximately 200HV along the 5 mm of the teeth profile.

recorded for the gear tooth flanks. Regarding the study of the hardness along the profile of the tooth, a decrease in hardness as the distance to the top of the tooth increased was observed, leading to conclude for the influence of carburization. On average, the hardness values tend to become constant after 5mm from the top of the tooth with the value of $470\text{HV} \pm 1.92\text{HV}$.

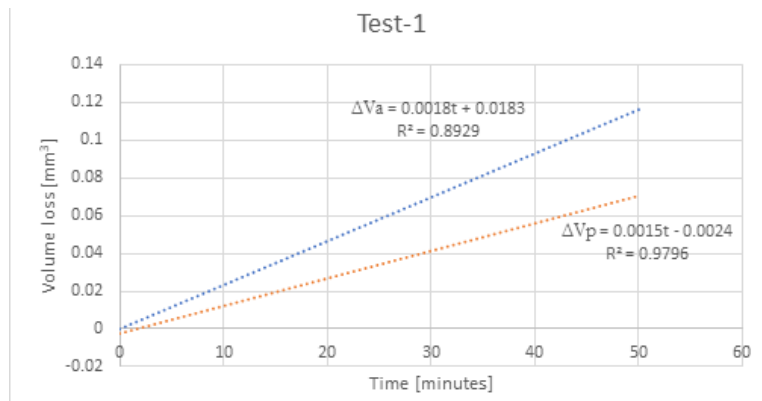
Fig 10 - Volume losses in specimen and pin, with applied load of 41,14N, for 50 minutes (Test-1)

The first test (Test-1) performed consisted in applying a 41,14N load, for 50 minutes, with stops each 10 minutes, to weight both samples and pin. The objective of this test was to estimate the rate volume losses for both sample and pin, that are given by the equations presented in Figure 10, in which ΔV_a is the volume loss of the specimen [mm^3], ΔV_p is the volume loss in the pin [mm^3] and t is the measure instant time [minutes].

First pin-on-disc dry test (Test-1) was made to estimate a loss rate of material [mm^3], to both sample and pin (equations 1 and 2), with a 41.14N load applied, at a rotation speed of 350rpm, with a 50 minutes test period. Stops were made each 10 minutes to weight both sample and pin.

$$\Delta V_a = 0.0018 \times t + 0.0183 \quad (1)$$

$$\Delta V_p = 0.0015 \times t - 0.0024 \quad (2)$$

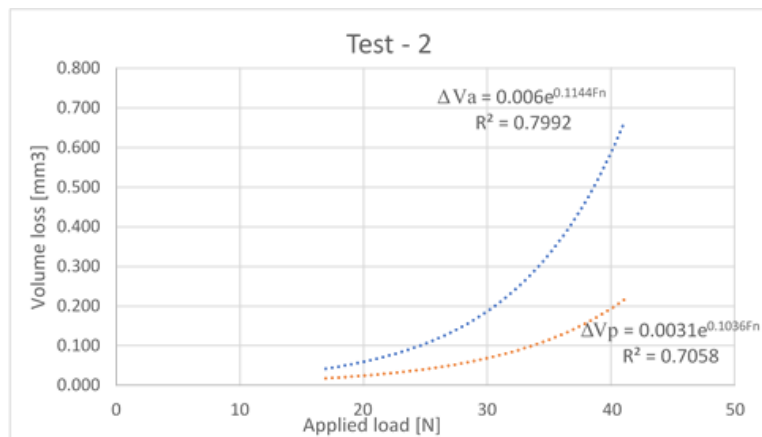
Fig 11 - Volume loss of specimen and pin in relation to the applied load (Test-2)

For the second dry test performed (Test-2) the objective was to evaluate the behaviour of the material when subjected to four different loads (16,83N, 30,84N, 34,35N and 41,14N). In Figure 11 it is presented the plot with the results from Test-2 and the equations and represent the exponential relations between the volume loss in both specimen (ΔV_a) and pin (ΔV_p) and the applied load F_N .

Second pin-on-disc dry test (Test-2) evaluated the volume loss in the material under different applied loads (16.93N, 30.84N, 34.35N and 41.14N), during 40 minutes at 350 rpm. In these tests the values of the friction coefficient registered were in the range 0.5 to 0.7 as expected. The registered values of friction force were 10N, 20N, 23N and 28N for test loads of 16.93N, 30.84M, 34.35N and 41.14N respectively. And the maximum temperatures registered in zone close to the contact area were 33°C, 41°C, 43°C and 44,8°C for the test loads of 16.93N, 30.84M, 34.35N and 41.14N respectively. Equations 3 and 4 were obtained for the specimen and pin, relating the volume loss of material [mm^3] to the different applied loads.

$$\Delta V_a = 0.006 \times e^{0.1144 \times F_N} \quad (3)$$

$$\Delta V_p = 0.0031 \times e^{0.1036 \times F_N} \quad (4)$$

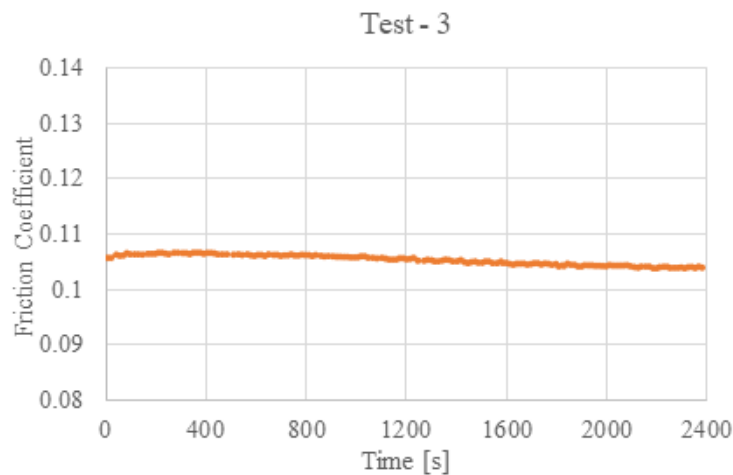
Fig 15 – Average friction coefficient obtained in wear used lubricant tests (Test-3)

Wear tests with used lubricant were performed (Test-3). In Figures 15 to 17 are presented graphics that relate the variation in time of the average friction coefficient, average

friction force and average temperature near the contact zone for the applied force of 82.75N. The biggest value obtained of volume losses for the specimens and pin, on the tests performed with used lubricant was 0.026 mm³.

A third pin-on-disc test (Test-3) was performed with old lubricant, during 40 minutes at 350rpm, with an applied load of 82.75N. The volume losses were insignificants to both specimens and pin. It was concluded that the friction forces, friction coefficients and the temperature close to the tip of the pin decreased, in average, 8.7N, 0.1 and 33°C, respectively.
