Failure analysis study of a tower crane collapse due to height increasing

Francisco Castro¹ | Nuno Viriato Ramos¹ | Francisco Queirós de Melo¹ | Pedro Moreira¹ | Mário Vaz^{2,1}

¹INEGI – Instituto de Ciência e Inovação em Engenharia Mecânica e Engenharia Industrial, Portugal
fcastro@inegi.up.pt; nviriato@inegi.pt; fmelo@inegi.up.pt; pmoreira@inegi.up.pt

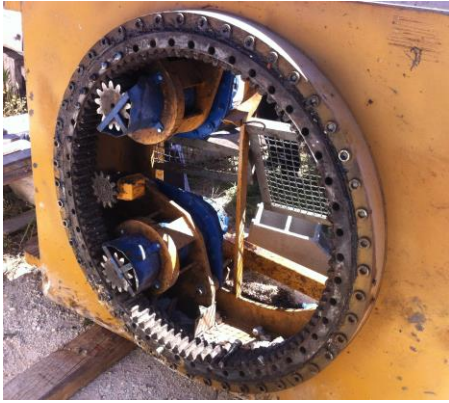
Fig. 9 | Slewing unit of the crane and its motors.

The slewing unit of the crane allows the boom to rotate because of its internal geared pinion/wheel driven by two electric motors (Figure 9). This unit is attached to the crane's tower by 48 bolts tightened with a pre-set torque, which started to fracture during the rotation (Figure 10). Some of them were projected away, while others remained in the respective holes. As can be seen the fracture

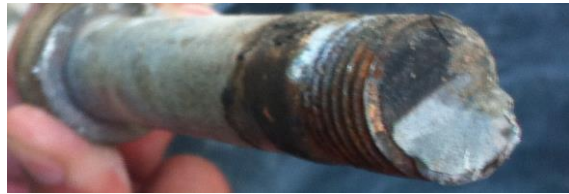
Fig. 10 | Detailed of the screw cross section evidencing brittle fracture.

section presents two distinct aspects: a lighter area corresponding to the final rupture and one darker, due to the existence of a propagated crack with corroded surfaces, a factor potentiating a faster crack growth velocity prior to the accident.

- 7) Connection bolts of the slewing unit; it was not checked how the manufacture assembled that unit or how regularly the bolted connection was inspected.

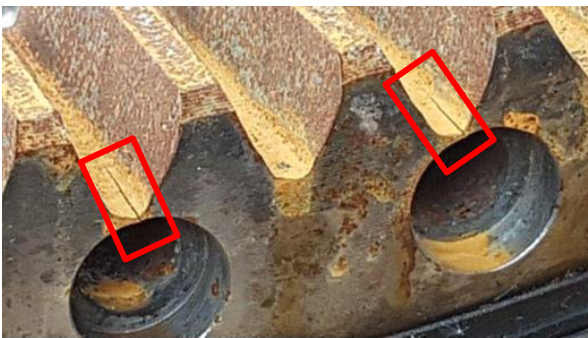
The visual inspection to the inner geared ring of the slewing unit, allowed the identification of at least two cracks close to the teeth root fillet, in a zone weakened by bolt hole machining (Figure 11). On the other hand, a detailed inspection revealed some irregularity marks where the pinion works (Figure 12), whose origin can be associated with the relative movements due to backlash between the two parts.

Fig. 11 | Detail of the rack where two fractures are identified.

- 6) Rack fractures; these fractures were not identified in the maintenance carried out to the crane. Its origin is related to irregular requests resulting from a defective gearing. If the pinion and rack axes are not parallel, there may be a variation in the gear middle-axes along the tooth width. Thus, part of the pinion tooth would get a little more inside the teeth of the rack, which would rise to an abnormal wear of the gear surface. Besides, the tooth flank is slightly concave, as would be expected if there is a lack of parallelism between the pinion and the rack.

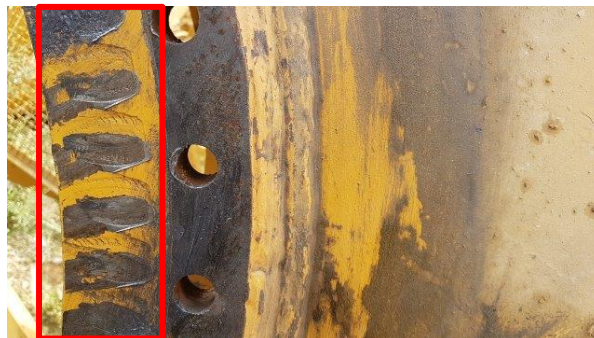
Fig. 12 | Detail of the top of the crane tower where irregular marks are visible.

- 5) Irregularities verified at the top of the tower; the presence of marks indicating the absence of lubrication mass raises concerns regarding potential misalignment of the pinion, which could lead to compression forces through contact in that area. Additionally, the presence of wear patterns resembling a cycloid suggests the possibility of a backrest being present during the movement. Consequently, these marks can be attributed to the dynamic forces associated with the collapse.

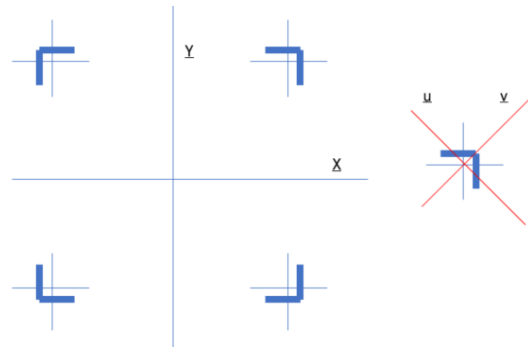
Major problems in the design of crane truss-type structural modules (beam and column) deal with compression forces, rather than tensile efforts. If these are combined with bending moments, they easily potentiate the buckling of each structure's single member, leading to a major collapse of the whole structural module. In this section, simple but essential design rules to a safer structure are reminded. Considering the following example, a truss-type column having a square section (Figure 13).

Fig. 13 | Truss-type column with a square section.

Now, let's assess the critical load for each single L-beam. Considering the minor section moment of inertia in bending (as indicated by the small figure near the main tower section in

Figure 13), the corresponding radius of gyration is 15,5 mm (about axis u).

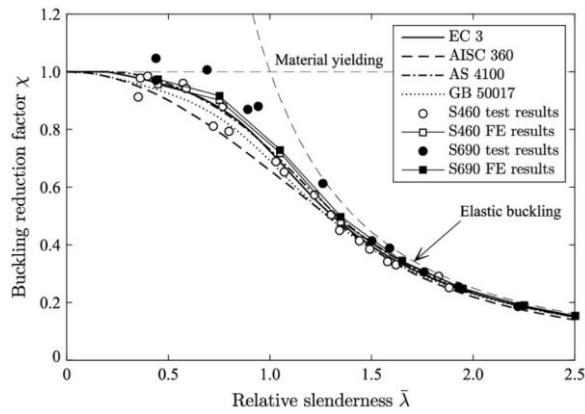
Fig. 14 | Relation between relative slenderness and the buckling reduction factor [12].

According with the graphic presented in Figure 14[12], the global reduction factor is about 0,45 for a slenderness $\lambda = 133$. (relative slenderness is real value divided by 100)

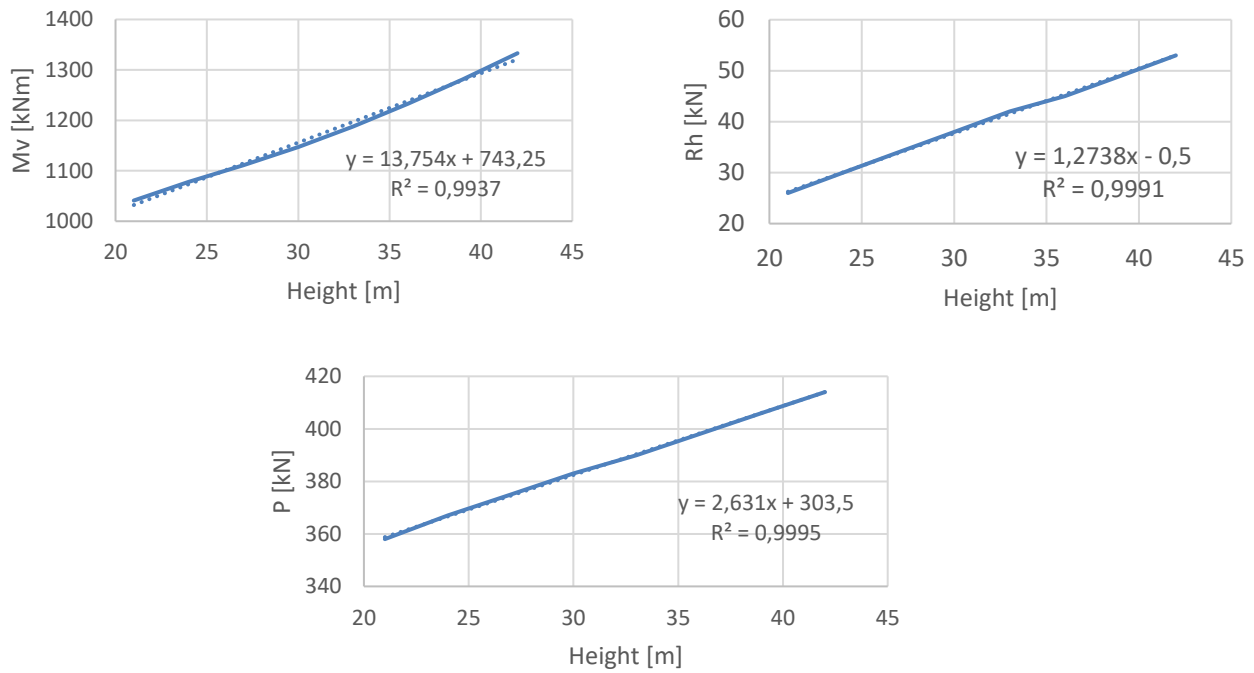
By fitting a function to the values provided for each of the three parameters as a function of height (Figure 19), it's possible to check that all of them vary linearly, being feasible to extrapolate each of these parameters to a height of 60 m. Performing a linear regression for each parameter where an equation is obtained, allowing the calculation of values corresponding to a height of 60 m.

Fig. 19 | Relationship between the parameters (P, Rh, Mv) and the crane height.

Substituting the “x” for 60 m in each equation, it is possible to determine the maximum permissible values for static requests for a height of 60 m, yielding the following results:

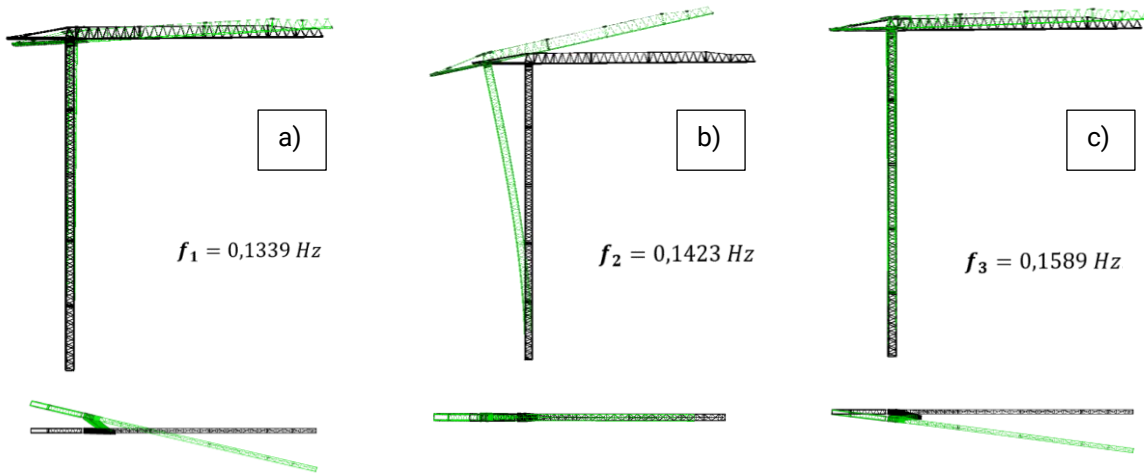
The dynamic simulation allowed to obtain the first three natural frequencies of the structure and its respective modes. Figure 20 depicts the maximum deformation position during oscillation around the equilibrium.

The first natural frequency obtained was $f_1 = 0,1339 \text{ Hz}$. In the first eigenmode, the tower and the boom are decoupled and there are some torsion of the tower and flexing of the boom, which is easily observed when operating the crane by twisting the main body whenever the boom is moved in rotation (Figure 20 a). In the second eigenmode, the tower and the upperpart are coupled behaving like a rigid body with both having an upward movement, with an oscillation whose natural frequency is $f_2 = 0,1423 \text{ Hz}$ (Figure 20 b). In the third eigenmode, the boom twists and the tower bends, as in the first mode, but with a lower amplitude of response, $f_3 = 0,1589 \text{ Hz}$ (Figure 20 c). The second eigenmode obtained corresponds exactly to the real collapsing dynamics of the tower crane under study.

Fig. 20 | a) first eigenmode; b) second eigenmode; c) third eigenmode.

The values obtained are very close to the three natural frequencies of the crane (0,1339 Hz; 0,1423 Hz; 0,1589 Hz), indicating that an oscillation in the suspended load can excite one of the crane natural frequencies. This can result in significantly high response amplitudes, potentially causing the crane to failure due to the inertia forces generated by the oscillation.
