# Quasi-static test on a half-scale two-story urm building: mechanical characterization of materials

## Ensaio quasi-estático num edifício em escala reduzida (1:2) de alvenaria não armada: caracterização mecânica dos materiais

The present paper focuses on experimental campaign of an unreinforced masonry building which represents the modern typology with concrete slabs, meaning that the structure ensures rigid diaphragm action. Accordingly, the paper is composed of two parts; (i) material characterization tests of masonry units and wallets through uniaxial, diagonal compression, and flexural tests on masonry wallets; (ii) design phase of the quasi-static test setup. The paper presents the key parameters that influenced decision-making of the design phase and general details of the test setup.

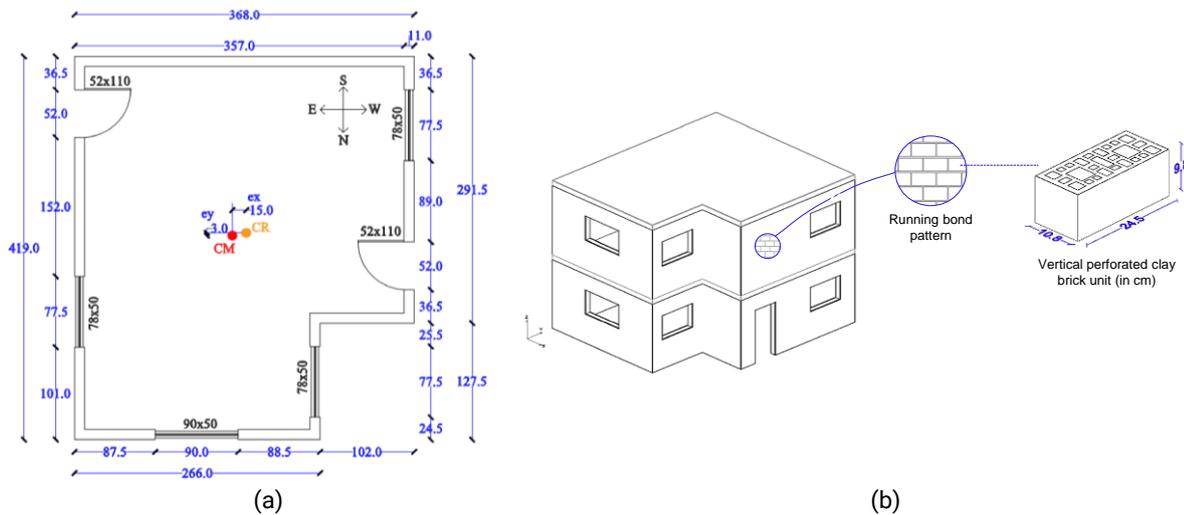
Fig. 1 | (a) Geometric details of the building plan, (b) axonometric view of the experimental building

This paper addresses the experimental campaign of (i) material characterization of masonry brick units, mortar, and masonry wallets, and (ii) the quasi-static test on a half-scaled two-story URM building and prediction of the test response. The first part is related with the characterization of the key mechanical behavior of masonry materials. For this purpose, (a) uniaxial compressive tests on mortar and masonry units; (b) flexural test on mortar specimens; (c) initial shear test for mortar-unit interface; (d) uniaxial, diagonal compression, and flexural tests on masonry wallets have been performed. The second part of the experimental work deals with the quasi-static test of a half-scaled two-story URM building with structural irregularity. The main goal is to have an insight on the response of a masonry building irregular layout and its failure patterns when subjected to lateral loading. To this end, a geometry similar to the experimental model tested by Avila et al. (2018) has been selected as illustrated in fig. 1. The half-scale two-story URM building has a plan dimension of 419 cm x 368 cm with an inter-story height of 152 cm (Fig. 1(a)). Furthermore, the box-behavior will be ensured by a RC slab, which has a 10 cm thickness. Due to irregularities in plan and elevation, center of mass and center of rigidity do not coincide with each other, resulting eccentricity of 15 and 3 cm in X and Y direction, respectively. The building is composed of vertical perforated clay masonry brick units which are already available in the market. The masonry arrangement has been decided as a running bond with the interlocking of the intersecting orthogonal walls. In literature, it is observed that there are different regularity definitions among the engineering community (Aşıkoğlu et al. 2021). Even so, the structure has so-called plan irregularity in which a setback in one corner occurs. Additionally, distribution of the openings along the elevation can be identified as irregular.

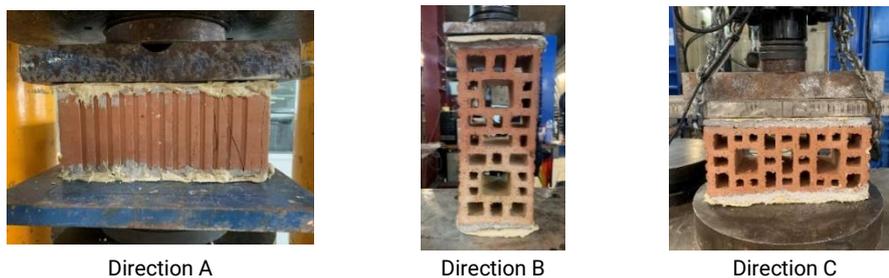
Fig. 2 | Compression test on brick units in different directions

The dimensions of clay masonry brick units are 24.5 cm x 10.8 cm x 9.8 cm. As per Eurocode 6 (2018), the clay masonry material is classified as Group 3. The compressive strength of the brick units was obtained according to EN 771-1:2000 (2000). For the compression tests, three directions were considered given the anisotropic nature of the vertical perforated brick units, such as in the direction parallel to perforations (direction A), and direction perpendicular to perforations (direction B, C), as shown in Fig. 2. Six specimens were tested for each direction and the results are summarized in Table 1.

Direction A	Direction B	Direction C
$F_{max}$ (kN)	231.4	18.4	126.8
$\sigma_{gross}$ (MPa)	8.7	0.7	4.8
$A_{gross}$ (mm <sup>2</sup> )	26460	10584	26460
$\sigma_{eff}$ (MPa)	15.0	3.5	9.6
$A_{eff}$ (mm <sup>2</sup> )	15428	5292	13230

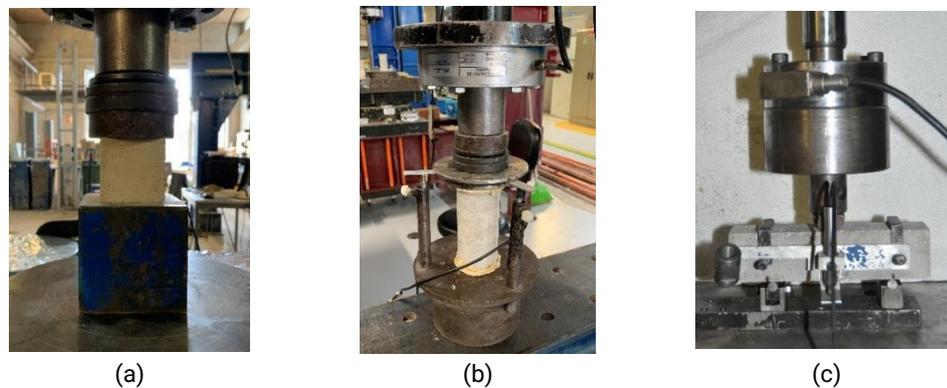
Fig. 3 | Hardened mortar tests, compression on (a) cubic, (b) cylinder samples, (c) flexural test

Class M10 ready-mixed mortar is chosen for bed and head joints. The compressive and flexural strength of the mortar was attained according to the EN 1015-11:2007 (2007). The mortar tested was a pre-mixed M10 mortar, used for the head and bed joints. In total, 13 cubic and 7 cylindrical specimens were tested under compression, Fig. 3. The average compressive strength was obtained as 13 MPa and 8 MPa, respectively. Moreover, the average flexural strength of the mortar was attained from 7 specimens.

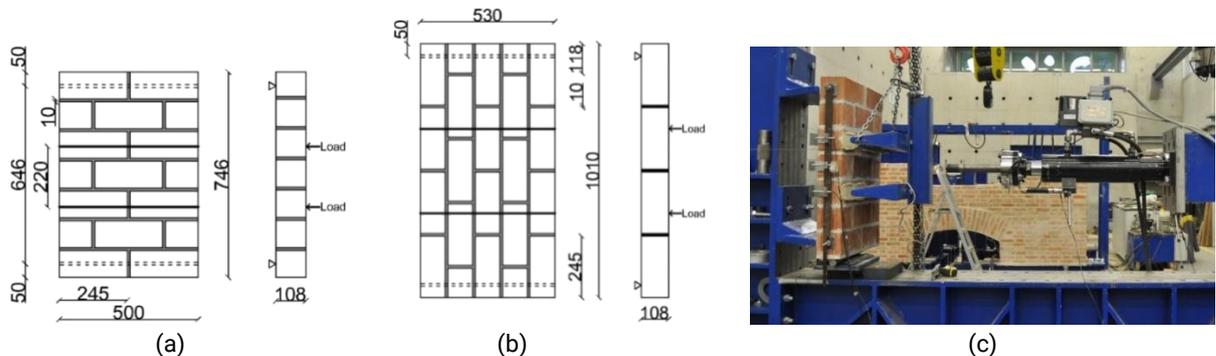
Fig. 4 | Detail of the flexural test specimens, (a) failure plane parallel to the bed joints, (b) failure plane perpendicular to the bed joints (in mm), (c) general view of four-point bending test setup for flexural tests.

The LVDT's were placed along the length of the specimen, one being in the middle of the specimens and the other two being at the loading points.

The flexural tests were designed and carried out according to BS EN 1052-2 (1999). To evaluate the flexural strength of the masonry wallets under pure bending, four-point bending tests were performed. In total, ten specimens were tested, (i) five specimens for failure parallel to the bed joints ( $f_{xkl}$ ), (ii) 5 for failure perpendicular to the bed joints ( $f_{xk2}$ ). Thus, two different geometries were considered for the masonry wallets and the details of the wallets are presented in Fig. 4. The tests were performed in displacement control at a rate of 10  $\mu\text{m/s}$ . The test equipment was assembled on a steel frame including an actuator with a capacity of 200 kN. Three LVDT's were used to measure the deformation and one LVDT was located on the hydraulic jack to control the actuator displacement. The LVDT's were located horizontally to record the flexural deformation due to the configuration of the test setup in which the specimen was placed vertically, similarly to Silva et al. (2018). The main reason is to avoid the influence of the weight of the specimen and the loading beam on the response.

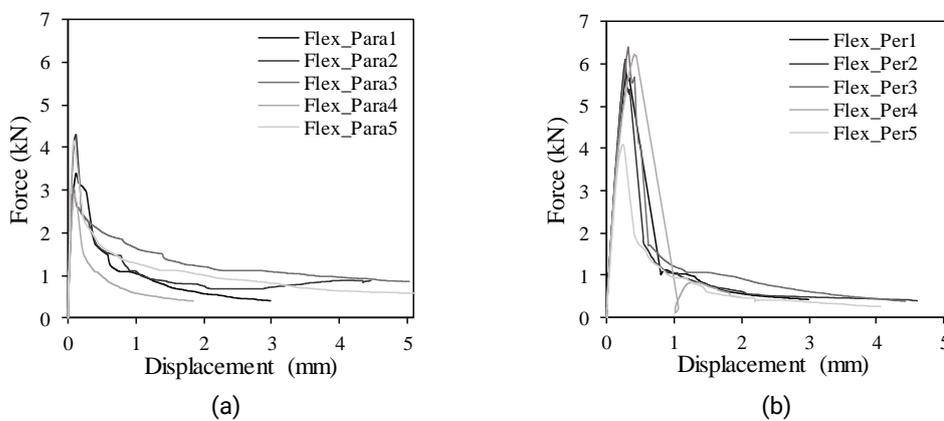
Fig. 5 | Flexural force-displacement plots, (a) failure parallel to the bed joints, (b) failure perpendicular to the bed joints

Accordingly, the flexural strength of each masonry wallet was calculated based on BS EN 1052-2 (1999) and the results are gathered in Table 2 and Fig. 5. The characteristic flexural strength parallel to the bed joint was found as 0.27 MPa, while the perpendicular counterpart was calculated as 0.51 MPa. It is noticed that the characteristic values obtained from experiments are almost 3 times and 1.25 times higher than the standard values given by Eurocode 6 (2018) for failure in parallel (0.10 MPa) and perpendicular (0.40 MPa) to the bed joint, respectively. This indicates that the standard underestimates the flexure capacity of this type of masonry.

Test	Parallel to bed joint				Perpendicular to bed joint			
	$F_{max}$ (kN)	$f_{x1}$ (MPa)	$f_{x1}^{mean}$ (MPa)	$f_{xk1}$ (MPa)	$F_{max}$ (kN)	$f_{x2}$ (MPa)	$f_{x2}^{mean}$ (MPa)	$f_{xk2}$ (MPa)
1	3.39	0.38			5.77	0.77		
2	4.30	0.49			6.10	0.81		
3	3.05	0.35	0.40	0.27	6.39	0.85	0.76	0.51
4	2.92	0.33			6.23	0.83		
5	4.16	0.47			4.09	0.55

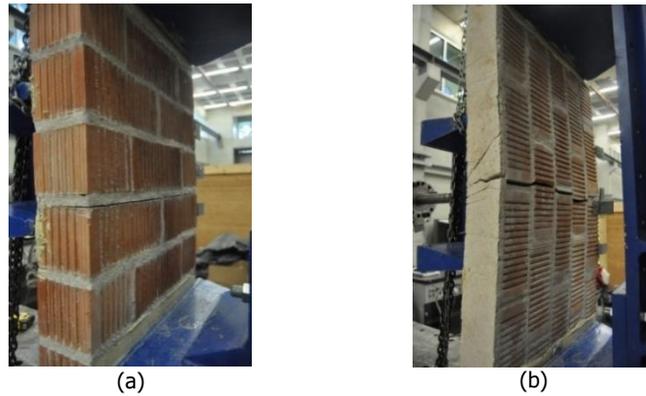
Fig. 6 | Typical failure mode, (a) parallel to the bed joint, (b) perpendicular to the bed joint

The failure of the mortar along the parallel bed joint was generally observed in a similar pattern for all test runs as presented in Fig 6(a). Internal webs of the vertical perforated brick units appear to provide interconnection at the unit-mortar interfaces through excess mortar during the laying. To what concerns the failure perpendicular to the bed joint, the damage was noted not only along with the mortar but also along with the brick units, as shown in Fig. 6(b). The failure mechanism of the specimens in parallel to the bed joint appears to be relatively more ductile than the specimens subjected to the loading perpendicular to the bed joint because of the failure of the mortar. On the other hand, brittle behavior was observed due to the failure of the brick elements.

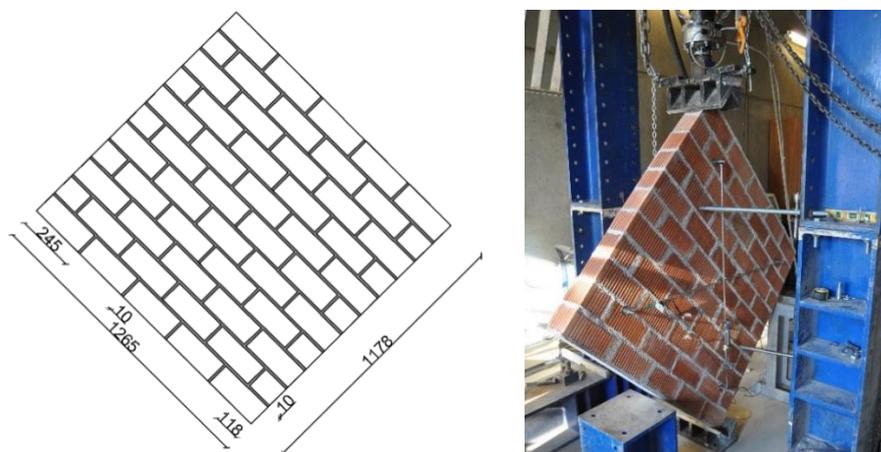
Fig. 7 | Specimen details and experimental configuration of the test (in mm)

Diagonal compression tests were carried out with respect to ASTM E 519 - 02 (2002). This test method allows to determine diagonal shear or tensile strength in masonry assemblages assuming that tensile principal stress is equal to the pure shear stress state. Six specimens were constructed by considering the dimensions given by the standard and the detail of the experimental setup is given in Fig. 7. In order to apply the diagonal compression, the specimens were placed in diagonal in between steel loading shoes which were positioned opposing bottom and top corners. Uniform application of the loading was ensured by rectifying the surfaces that were in contact with the loading shoes. All specimens were tested with an actuator of 500 kN load capacity and performed under displacement control at a rate of 2 mm/s. The test was controlled by a LVDT attached to the actuator and conducted until the failure was attained. At each façade of the specimen, 2 LVDT's were instrumented to measure (i) the shortening of the vertical diagonal parallel to the applied load, (ii) the opening of the horizontal diagonal perpendicular to the applied load.

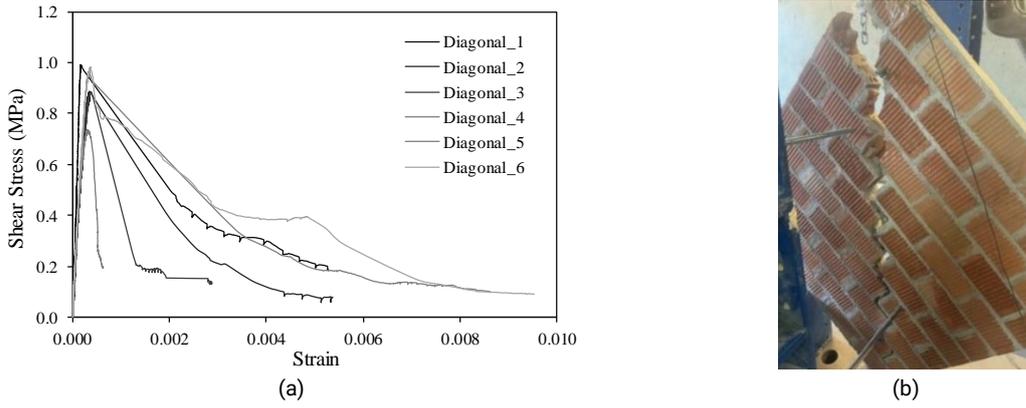
Fig. 8 | Diagonal compression test results, (a) stress-strain plot, (b) failure mode

The results of the tests are presented in terms of stress-strain relation in Fig. 8(a) and the mechanical parameters are listed in Table 3. The stress-strain plots illustrate the brittle behavior of shear failure. In general, maximum force, shear stress and shear modulus slightly differ, except the fourth specimen. Although stress and maximum force observed on the first specimen has reasonable agreement with other specimens, there is a peculiar difference in the shear modulus. The reason for such discrepancy might be due to an issue related with the measurement of the transducers that could lead unreliable result for that test run. Therefore, shear modulus obtained from the first specimen was disregarded for the calculation of the mean value.

Test	$F_{max}$ (kN)	$\tau_{max} = f_t$ (MPa)	G (MPa)
1	92.5	0.99	6050
2	82.7	0.89	2594
3	82.5	0.88	2309
4	68.7	0.74	2361
5	90.0	0.96	3008
6	91.7	0.98	2686
Average	84.7	0.89	2592*

It is noted that the maximum force attained at the fourth specimen was significantly lower than the other test runs. The specimen failed along the mortar bed joint of the second row of brick units. Thereupon, detachment of the mortar prevented the load flow below the crack. Under such circumstances, it is believed that the mortar bed joint which suffered from damage was the weakest link throughout the specimen. In other words, time difference due to workmanship or possible difference in the mortar mixes might influence the response. On the other hand, typical diagonal damage pattern was observed on the other specimens. Once the peak stress was achieved, the assemblages mainly collapsed in a sudden and brittle way in which stepwise crack was occurred, Fig 8(b). Consequently, the average of the diagonal shear strength and/or tensile strength of the present masonry wallets is found as 0.89 MPa while the average shear modulus is 2592 MPa.

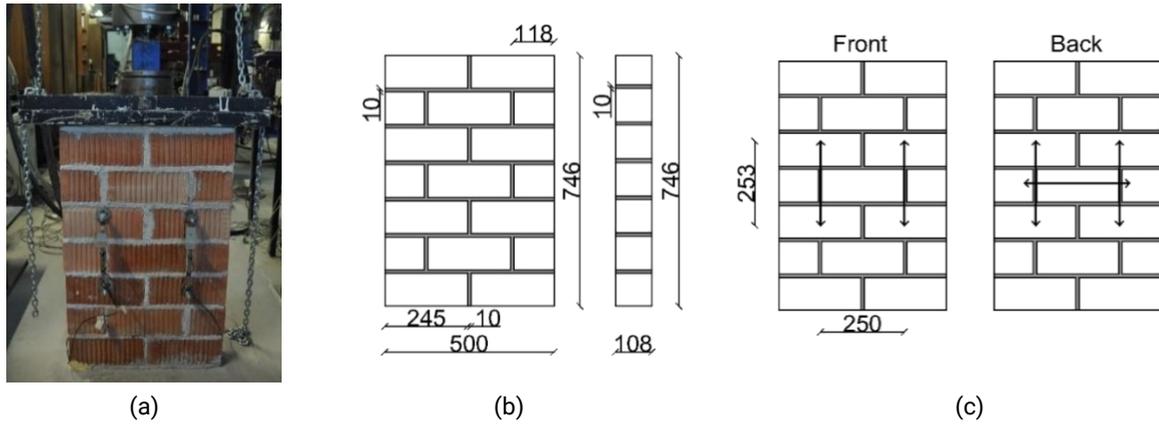
Fig. 9 | Uniaxial compression test, (a) setup, (b) geometric details, (c) LVDT configuration (in mm)

The compressive strength of the masonry wallets was determined by performing uniaxial compression test following the standard, BS EN 1052-1 (1999). Three specimens were constructed according to the standard prescriptions. The details of the specimen and test setup are presented in Fig. 9. The test instrumentation consisted of a hydraulic actuator with a load capacity of 500 kN and five LVDT's to measure the deformation. The test was conducted under displacement control with a rate of 2 mm/s. The vertical load was applied on the top surface of the specimen to evaluate the compressive strength. For the first specimen, the load was applied with a constant increment starting from zero until the failure. However, the loading protocol was described according to the standard for other two specimens in order to determine the Young's modulus. The compressive

force was applied in three equal steps until the half of the maximum force that was attained from the first specimen. After each step, the compressive force kept constant for two minutes. Following to the last step, the force was increased at a constant rate until the failure. Fig. 10 illustrates the force-displacement and stress-strain relation of each specimen under uniaxial compression.

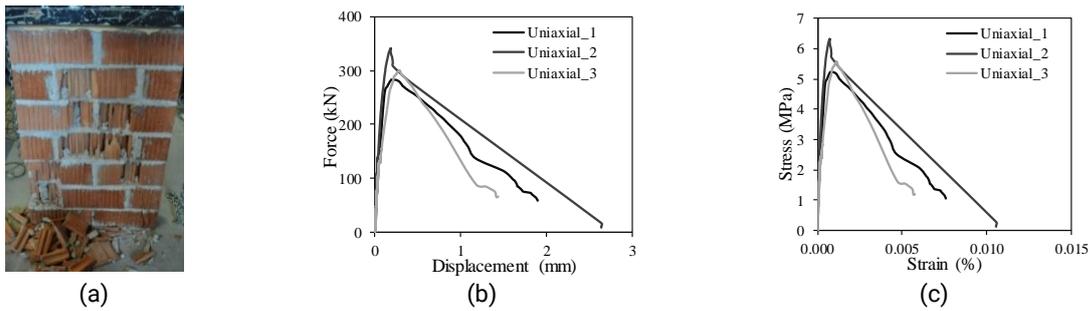
Fig. 10 | Uniaxial compression behaviour of the wallets, (a) failure mode, (b) force - displacement, (c) stress - strain curves

The mechanical parameters obtained from the test results are presented in Table 4. The mean compressive strength and the Young's modulus were determined as 5.7 MPa and 17518 MPa, respectively. Furthermore, the characteristic value of the masonry compressive strength is determined according to relation given by Eurocode 6 (2018) and, therefore, the minimum value is selected as resultant. In this context, the characteristic compressive strength obtained from the experimental campaign is 4.75 MPa. Additionally, the characteristic compressive strength and Young's modulus were calculated according to Eurocode 6 (2018) and given in Table 4. It is noted that compressive strength of the masonry unit and the mortar obtained from the experiments were taken account. Thus, it is possible to check the reliability of the uniaxial compression test results through the standard prescriptions. It is found that the experimental value is significantly higher (61%) than the values calculated based on the relation given in Eurocode 6 (2018).

All panels demonstrated brittle collapse in an explosive manner. Mainly, visual cracks appeared to occur along the head joints and propagated through the brick units, as depicted in Fig. 10. In general, the failure was governed by diagonal cracks which recognized as sand clock type shape. Yet, cracking and crushing especially at the bottom corner of the panels, as well as splitting of the shells and webs were observed at the end of the test. What concerns the damage propagation, it is believed that cracking initiated on the webs of the brick units due to the fact that a set of cracking noise was noticed in the first place.

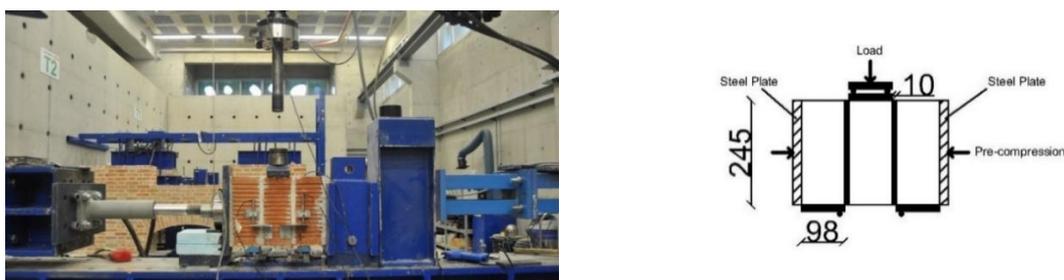
Fig. 11 | Configuration of the test setup for initial shear test and the details of the specimen (in mm)

Initial shear strength of the unit-mortar interfaces was obtained by performing triplet test based on BS EN 1052-3 (2002). According to the standard, three different stress levels with a value of 0.2 MPa, 0.6 MPa and 1.0 MPa were used since the compressive strength of the masonry units was higher than 10 MPa. For each precompression level, three specimens were tested. In total, 5 LVDT's were used, one of them was used to control the actuator displacement while other 4 were placed at the two façades of the specimen as shown in Fig. 11. Vertical LVDT's measured relative displacement with respect to the center of the course and a horizontal LVDT was used in order to record any opening between the units that could happen. The shear force was applied under displacement control at a rate of 10 mm/s while precompression was applied by using a manual hydraulic jack.

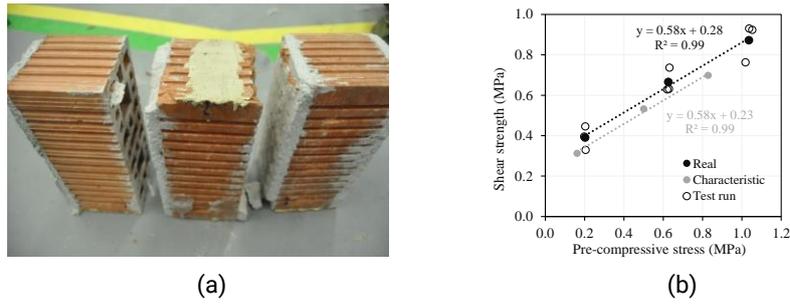
Fig. 12 | (a) Failure mode, (b) relation between maximum shear strength and pre-compressive stress

The deformation of the specimens was measured by means of LVDT's and given in Fig 12 (a). For each specimen, shear strength ( $f_{voi}$ ) and precompression stress ( $f_{pi}$ ), and characteristic initial shear strength (or cohesion) were calculated. Moreover, correlation of the maximum shear strength and pre-compressive stress is illustrated in Fig 12(b). Definition of the linear regression of the points allows to obtain (i) initial shear strength under zero precompression ( $f_{v0}$ ) which is the interception of the obtained line with zero precompression stress, (ii) friction coefficient ( $\mu_0$ ) which is the slope of the obtained line, (iii) internal friction coefficient ( $\alpha_0$ ) which is the angle of the obtained line, and their characteristic values ( $\mu_k, \alpha_k = 0.8 \tan \alpha_0$ ).

Briefly, shear properties of the unit-mortar interface obtained from the tests are listed in Table 5. The characteristic initial shear strength is found as 0.23 MPa which is nearly 33% less than the standard value (0.30 MPa) given by Eurocode 6 (2018). The specimens showed two types of failure mode which is defined in BS EN 1052-3 (2002). It was observed that the failure mode was governed by the level of precompression. For instance, the specimens, which were tested with the lowest precompression level (0.20 MPa), presented shear failure along the mortar-unit interface while the failure under higher level of precompression was observed as splitting in the brick units.

PreComp_0.2	PreComp_0.6	PreComp_1.0
A (mm <sup>2</sup> )	26460	26460	26460
F <sub>i,max</sub> (kN)	4.9	15.1	24.9
f <sub>pi</sub> (MPa)	0.2	0.6	1.0
F <sub>max,i</sub> (kN)	18.8	32.0	41.9
f <sub>voi</sub> (MPa)	0.35	0.60	0.79
f <sub>vo</sub> (MPa)		0.28	
f <sub>vok</sub> (MPa)		0.23	
μ <sub>o</sub>		0.58	
μ <sub>k</sub>		0.58	
α <sub>o</sub> (°)		30.1	
α <sub>k</sub> (°)		30.1

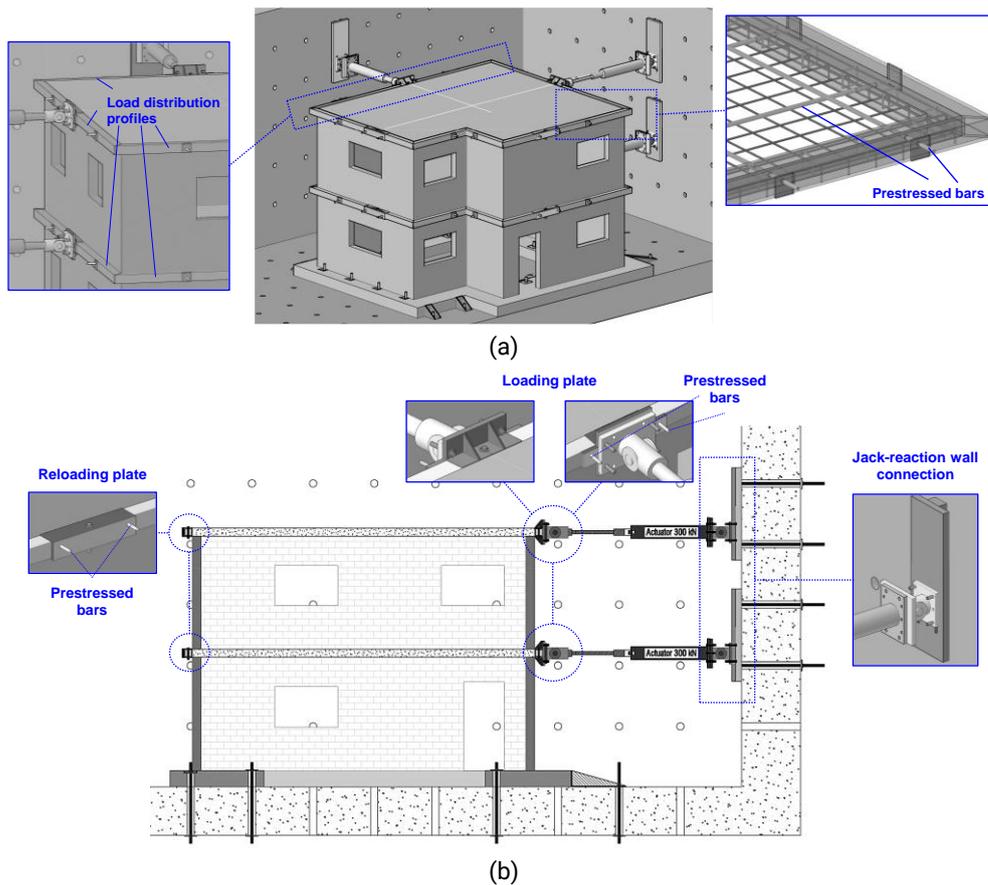
Fig. 13 | Configuration and details of the experimental setup, (a) 3D view, (b) section view

In this section, designing and planning procedure of the half-scale quasi-static test is addressed. Since the experimental campaign has not been started yet, a preliminary planning and key parameters that influenced the decision-making of experimental design is delivered, as depicted in Fig. 13. Preliminary numerical analysis allows to predict the response of the building and design and decide the components of the experiment. For instance, based on the analysis carried out by (Aşıkoğlu et al. 2020a) and (Aşıkoğlu et al. 2020b), a hydraulic actuator with a capacity of 300 kN at each level would be enough. Indeed, the hydraulic jacks is planned to be located along the axis of the center of mass to represent better the dynamic actions that activates the mass of the structure. However, it is decided to implement tube profiles along the perimeter of the building in order to avoid concentration of the load at one point (Fig. 13 (a)). Furthermore, once building is subjected to residual damage, i.e., inelastic range, it is necessary to safeguard its adjustment at the reference (zero) point during the reloading phases. In this sense, several prestressed bars will be implemented with a spacing of 75 cm along the length and width of the structure, as shown in Fig. 13 (a). These prestressed bars will be embedded in the RC slab, and they will be fixed to loading and reloading plates via load distribution profiles.
