IMPACT BEHAVIOUR OF LOW FIBRE-FRACTION GLASS / POLYESTER LAMINATES

Sutherland, L.S.¹ and Guedes Soares, C.²

Unit of Marine Technology and Engineering, Instituto Superior Técnico
Av. Rovisco Pais, 1049-001 LISBOA

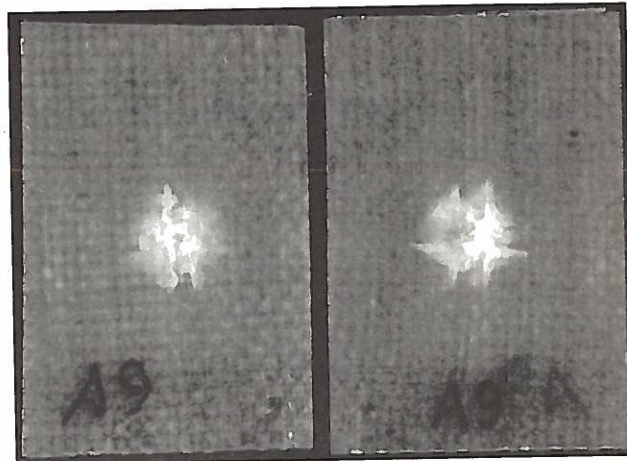
Typical damage modes are shown in Figure 2 and Figure 3.

Figure 2: WR Specimen Low Energy Damage (Front and Back)

The damage sustained by the woven roving specimens may be grouped into three main categories; Front face buckling delamination under the impactor, internal shear delamination and back face matrix and fibre degradation.

The front face and internal delaminations were approximately circular for lower impact energies, but became progressively miss-shaped and elongated in the warp direction (the direction parallel to the long edge of the clamp) as the severity of impact increased. The back face damage consisted of a central area of matrix cracking and progressive degradation, and then associated fibre damage and failure at medium and high energies respectively.

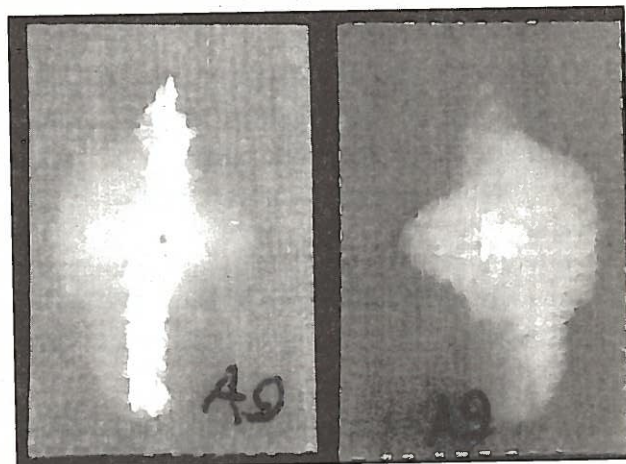
Figure 3: WR Specimen High Energy Damage (Front and Back)

As the highest energies were reached, specimen failure occurred either in the form of varying degrees of perforation of the specimen by the impactor, or by a line of shear failure from the centre of the specimen to the centre of the long edge of the clamp. The final failures of the 500 gm^{-2} laminates were through perforation for the 5-ply specimens and through shear for the 10-ply specimens. Final failure of the 15-ply specimens was not seen. The 3-ply

500 gm^{-2} specimens failed in shear (with the exception of one perforation), and the 6-ply specimens failed in shear and perforation in equal numbers.

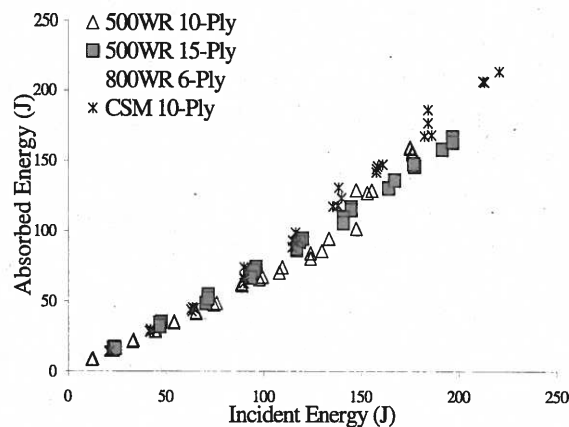
The relationship between the energy permanently absorbed by the specimen (mainly in the form of material damage) and the incident energy for all laminates is shown in Figure 5 and Figure 6.

There are two main bi-linear trends, one for the thinner laminates and one for the thicker laminates. Both show an initial section where the absorbed energy (AE) is approximately 2/3 of the incident energy (IE), followed by a second section where the slope increases to approximately 3/4. This change in slope occurs when the more severe, final failure damage modes start.

Figure 6: Absorbed Energy, Thick Laminates

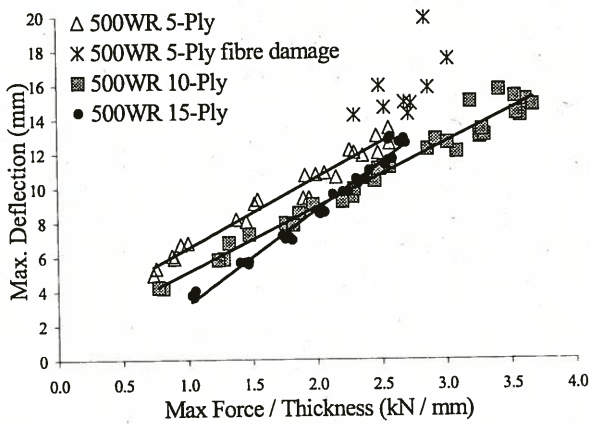
Plots of w_{Pm} vs. (P_m / t) for the WR data give good linear correlation at lower energies. At higher energies, as back face damage leads to perforation, deviations from the line are clear for the 5-ply 500gm⁻² WR specimens (Figure 7). Although not as marked, deviations are also seen at the highest energies for the equivalent 10 and 15-ply specimens.

Figure 7: Eqn. (2): 500gm⁻² WR Data

Perforation of the 5-ply specimens is again evident, but not as clearly as in Figure 7. Some deviation from the line at higher energies for the 15 ply data could indicate that more severe, but unseen, damage is present. However, the 10-ply data final shear failures are not visible in this plot.

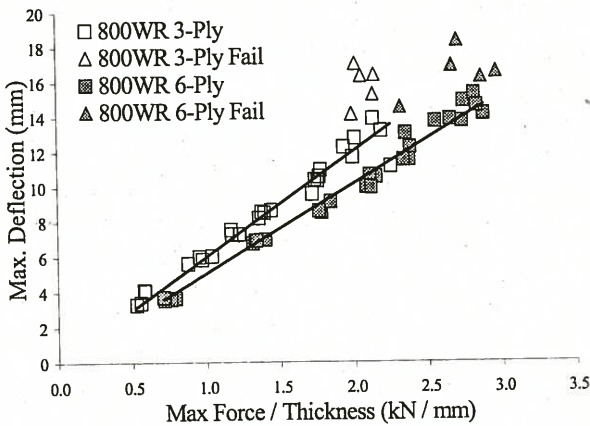
The final failure of both the 3 and 6-ply 800gm⁻² specimens are clearly seen in Figure 8.

Figure 8: Eqn. (2): 800gm⁻² WR Data

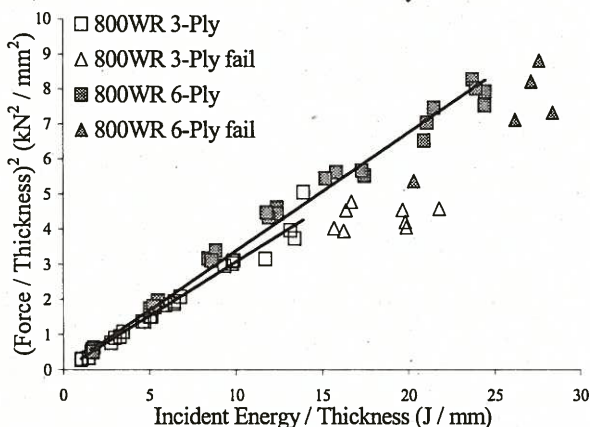
Strong linear relationships and clearly indicated final shear failures are shown in the equivalent plot for the 800 gm⁻² WR data (Figure 11).

Figure 11: Eqn. (4): 800gm⁻² WR Data

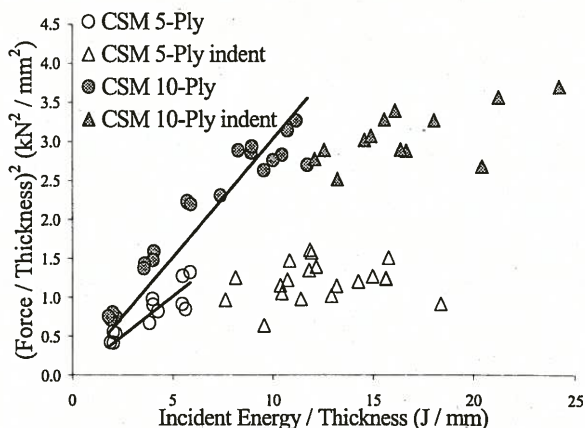
The onset of indentation can be clearly seen for the CSM laminates in Figure 12. Possibly this plot could be used to more revise the definition of the beginning of more severe damage for the 10-ply currently assessed visually.

Figure 12: Eqn. (4): 800gm⁻² WR Data
