Degradation of Concrete Bridges by Internal Expansive Reactions – Portuguese Case Studies

António Santos Silva, Arlindo Gonçalves, Manuela Salta

Materials Department, Laboratório Nacional de Engenharia Civil, Av. Brasil 101, 1700-066 Lisboa, Portugal

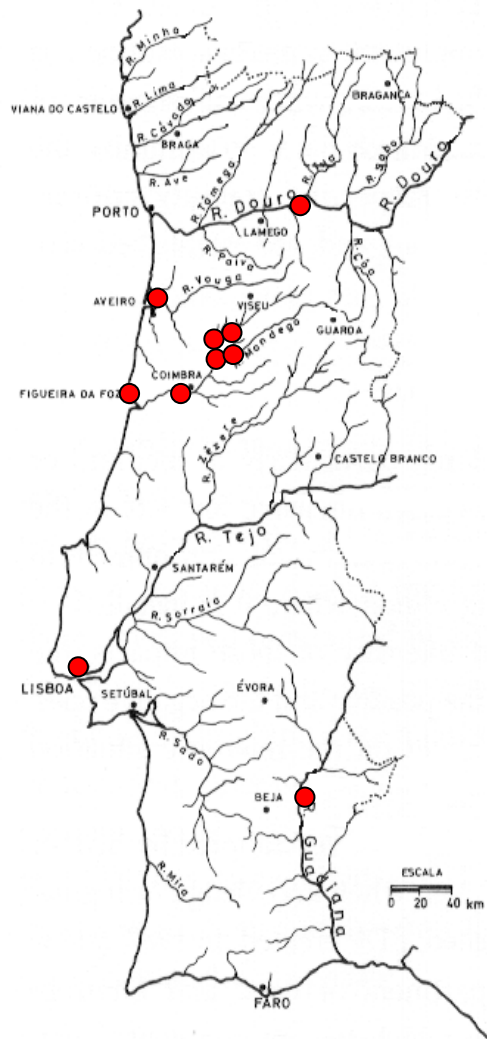
Figure 1 – a) Simplified map of Portugal with the locals of some reported cases of concrete bridges affected by ASR and DEF; b) SEM image of a concrete showing a pore in the cement paste filled by DEF; c) SEM image of ASR products in a concrete.

In recent years have been discovered in Portugal several cases of reinforced concrete bridges damaged by internal expansive reactions (figure 1a). The number of cases is already significant enough to make known this disease and the methods to be used in the existing structures for its diagnosis, and the mitigation forms in the new structures.

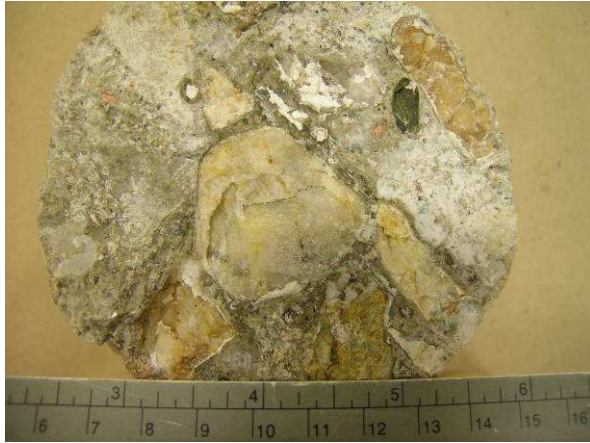
In this case study a simple macroscopic observation of the cores taken in the most cracked zones of the structure, reveals the occurrence of products filling pores and in the aggregate-paste interfaces (figure 2a), which is a important feature normally associated to internal expansive reactions. The optical and electronic microscopical observations confirmed the degradation cause is ASR and DEF (figure 2b), which in this case was a consequence of the use of alkali-reactive siliceous aggregates and the relatively high cement (CEM I) content employed ($>350 \text{ kg/m}^3$).

Figure 2 – a) Detail of a concrete core showing the presence of with products filling voids and aggregate/paste interfaces; b) Image obtained at polarizing microscope of a concrete thin section showing the presence of veins of DEF (1) and ASR gels (2) along the paste.

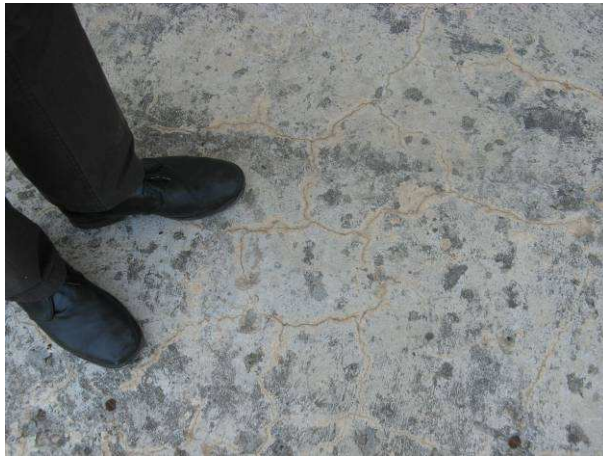
After 10 years in service, it was detected the presence of extensive map-cracking in some piers and in the massive cap piles. The cracking pattern induced the suspicion of internal expansive reactions occurrence in the concrete - figure 3a.

Figure 3 – a) Detail of the map-cracking in a concrete pile cap; b) Image of the concrete at petrographic microscope showing a void with an irregular shape partially filled with DEF near a aggregate/paste interface.

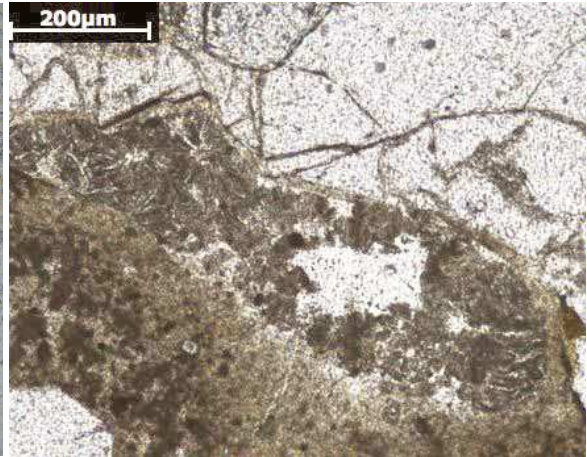
b)

The diagnosis tests showed the presence of ASR, due to the use of alkali reactive granite aggregates, and also DEF. The DEF has been associated with the high cement content and also to very massive structural elements. Note that the combination of ASR with the DEF could be simultaneously, since the ettringite is not stable in concretes with high alkali contents. In these conditions, the sulfate ions do not have been combined during the setting of the concrete and are available in the interstitial solution of concrete to precipitate later as delayed ettringite.
