McFarland Associates Limited

2nd Transnational Workshop
duratiNET
The Queen's University of Belfast
22nd June 2009

Carbonation, Chlorides & Electrochemical Repair

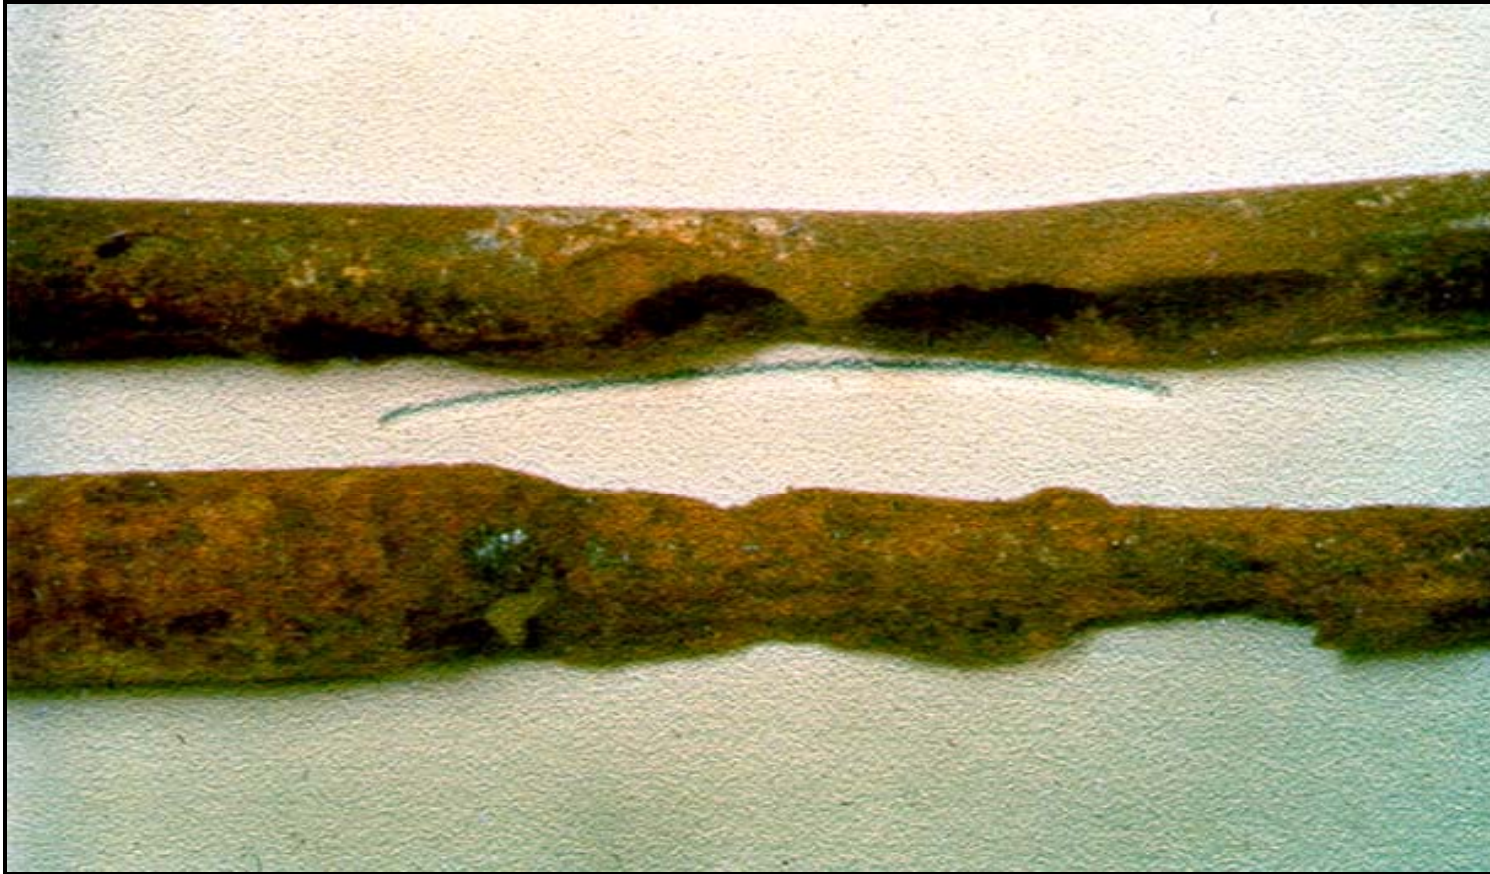
Chloride induced corrosion pits

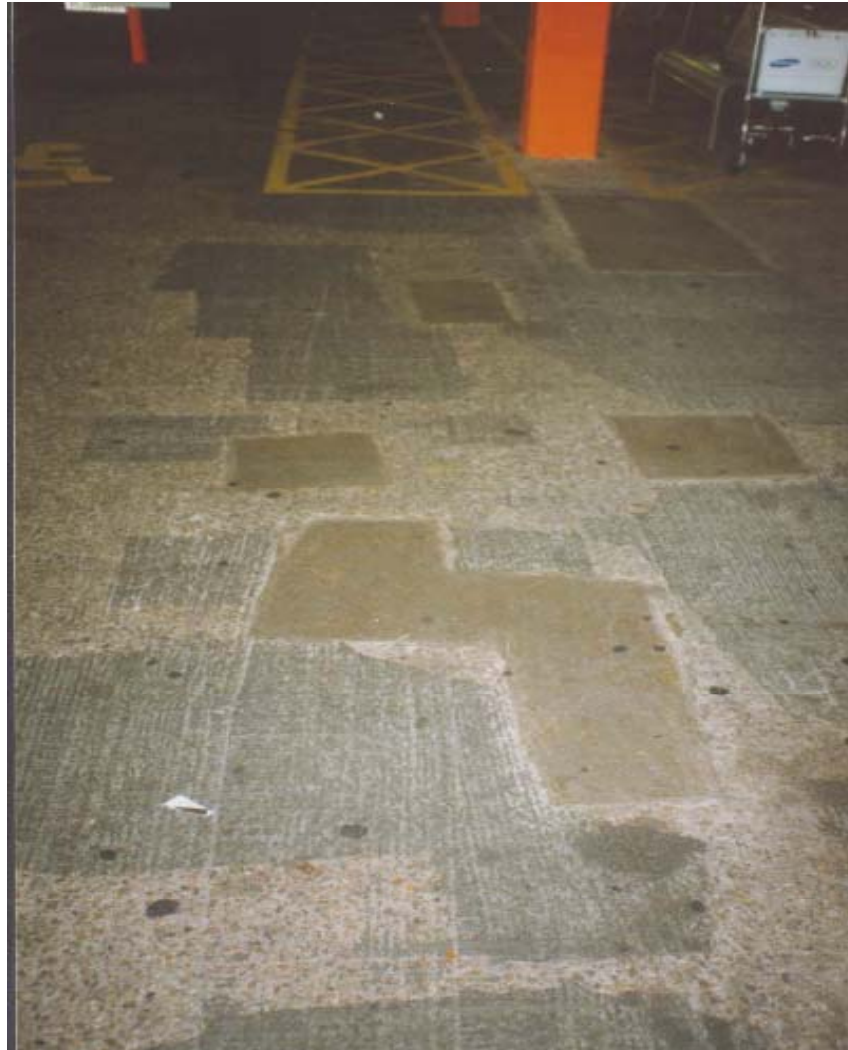
Chasing the corrosion

The problem ... “the newly established cathodic area within the repair will drive the new anode site in the contaminated region”

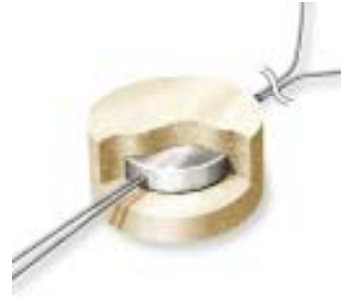
XP

for patch repairs

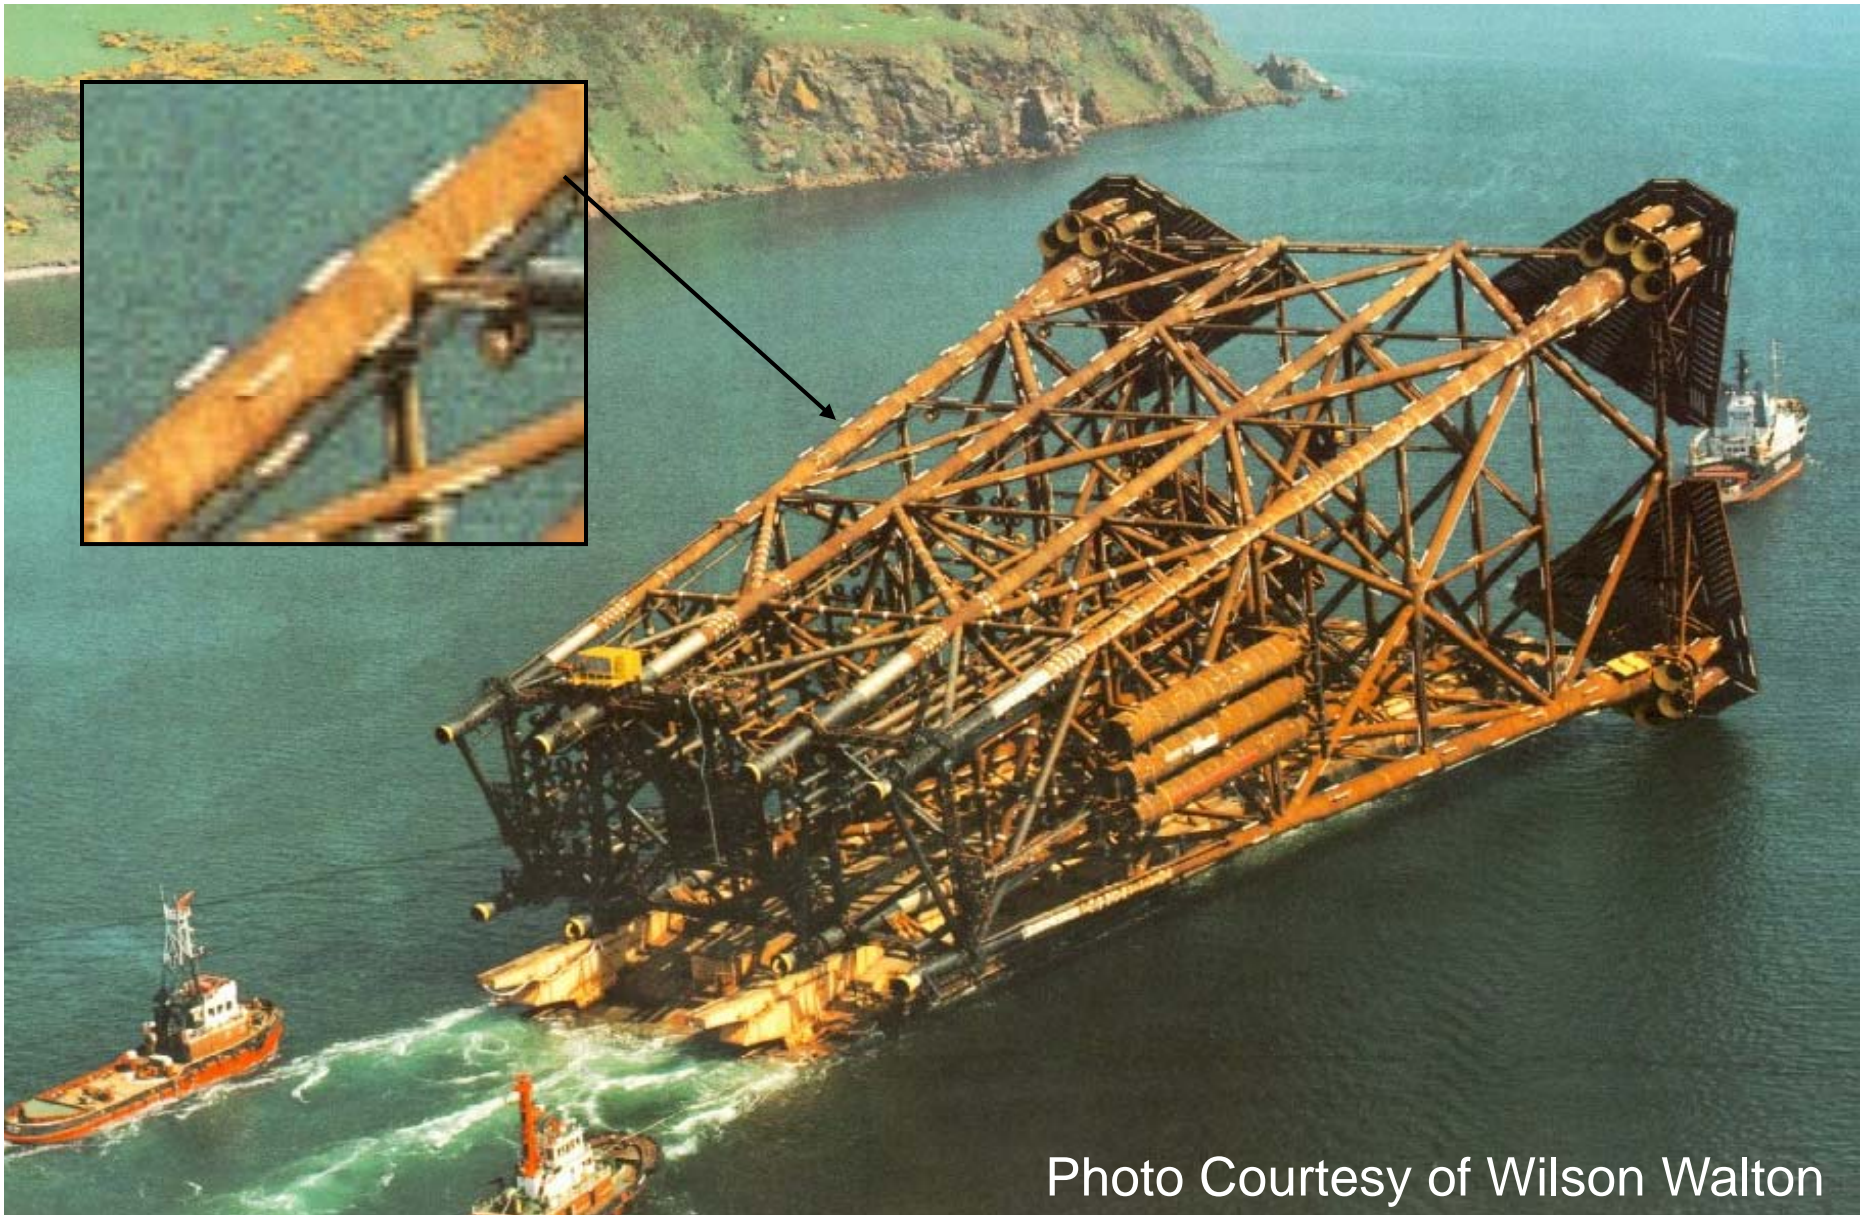
Oil Rig Example

- Chloride extraction type process
- Cathodic prevention type process (low maintenance)
- Single electrode system

- Install discrete alloy electrodes
- Apply specialised electrochemical treatment for 1 week
- Connect activated sacrificial anode to steel

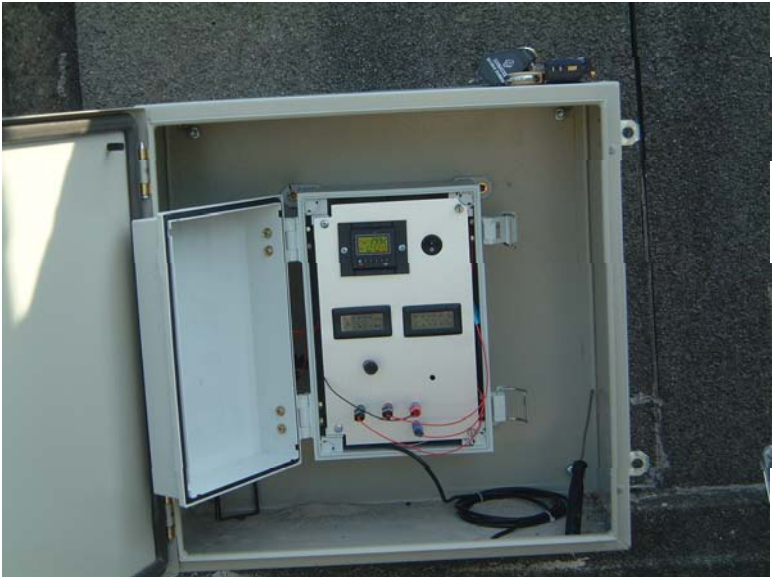
Automated monitoring box

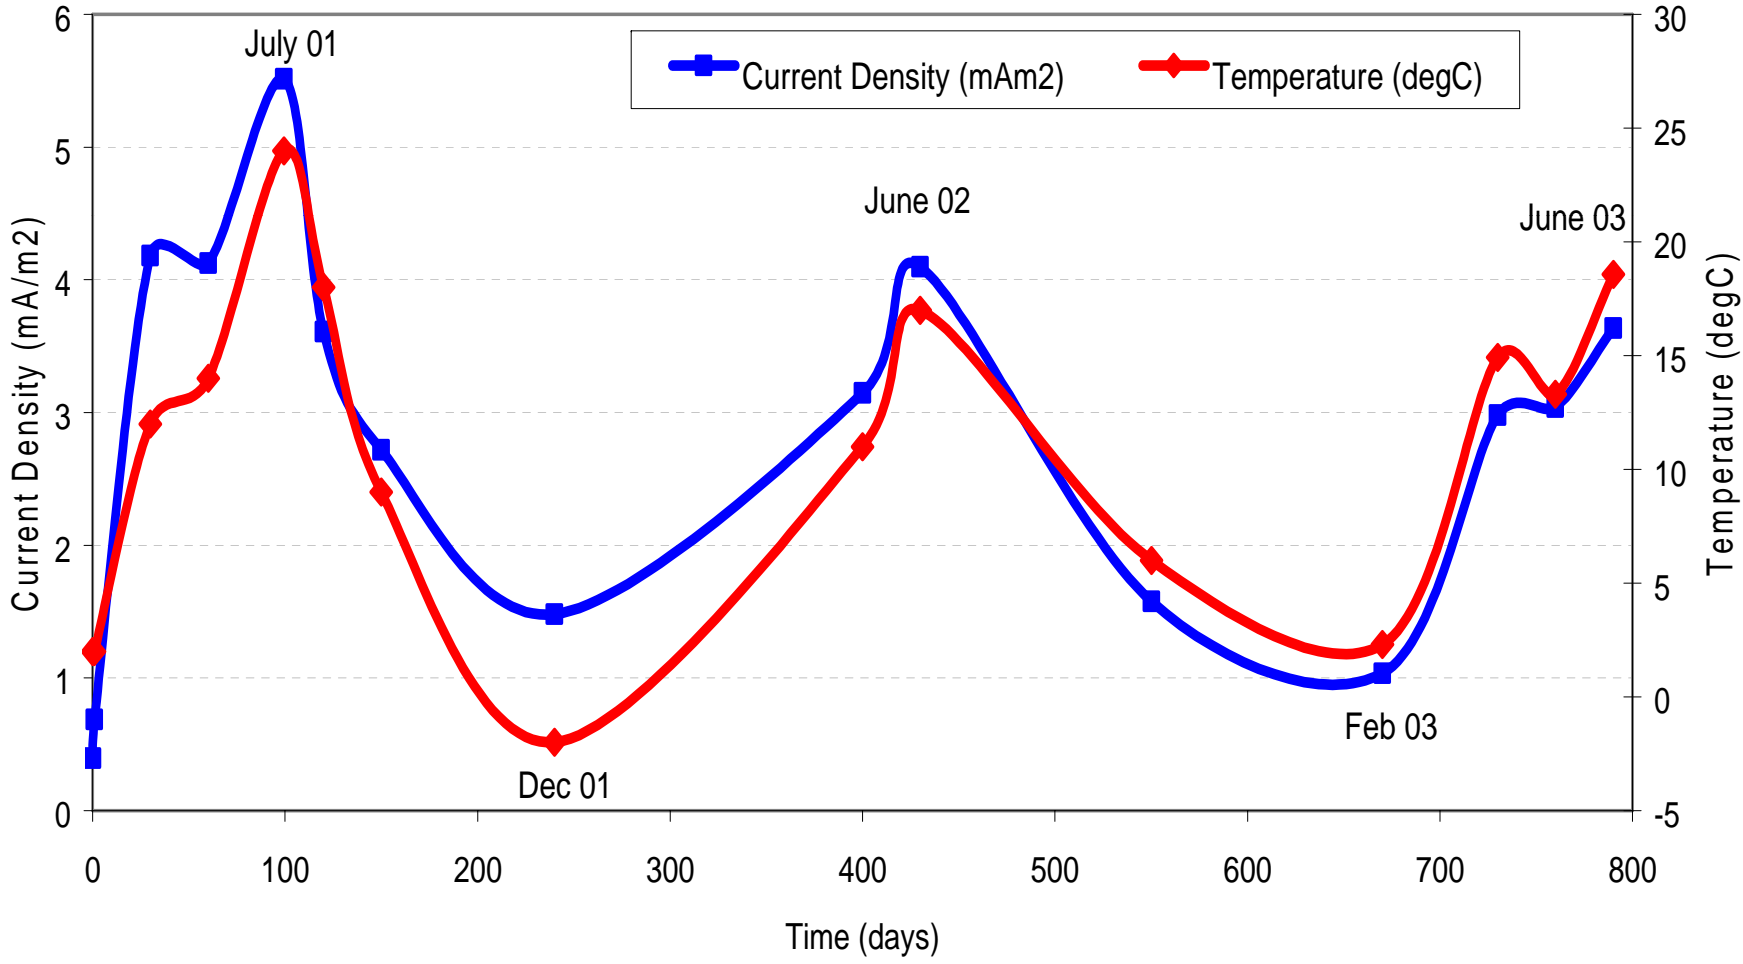
Current output can be easily monitored

Eaton Park Pavillions, Norwich: CC anodes installed April 2001:Current Density results

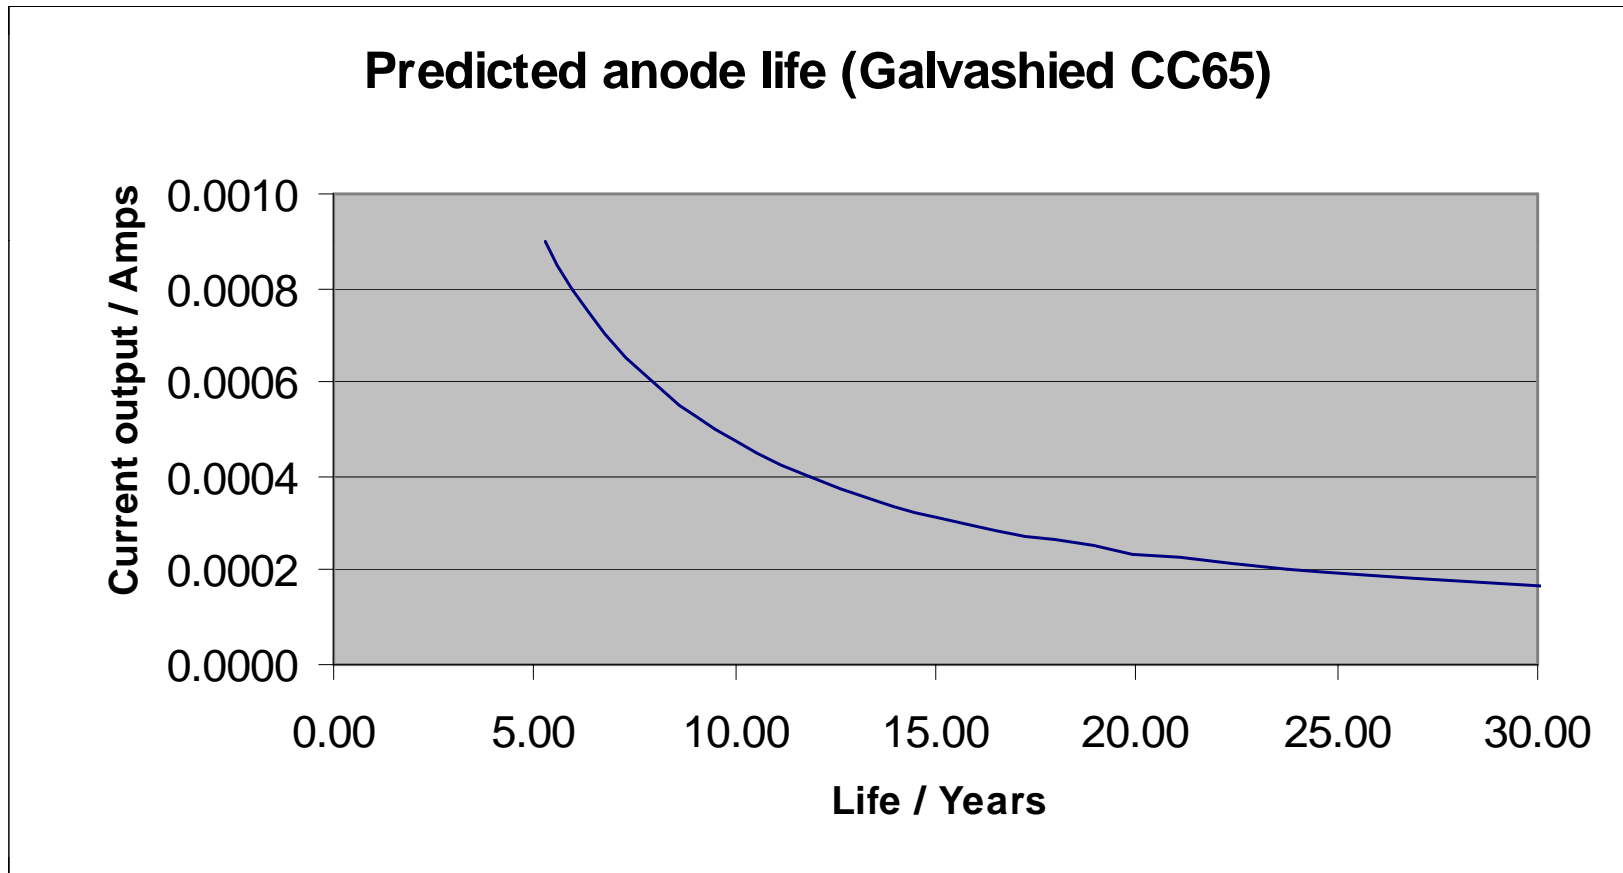
Residual life can be calculated
