LABORATÓRIO NACIONAL DE ENGENHARIA CIVIL

LABORATORY AND MICROSTRUCTURAL TESTS ON THE DETECTION AND PREDICTION OF AAR

António Santos Silva[1] & Isabel Fernandes[2]
1 - Materials Department, LNEC
2 – Department of Geology, Environment and Land Planning (DGAOT), University of Porto

One Day Course on AAR
Lisbon, 14th February 2011

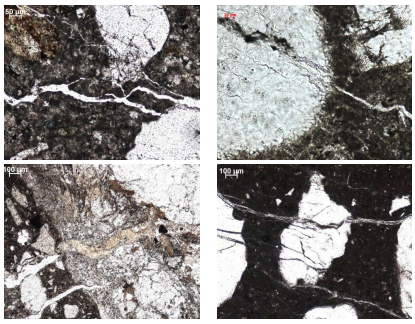
- Microscopic examination – micro cracks

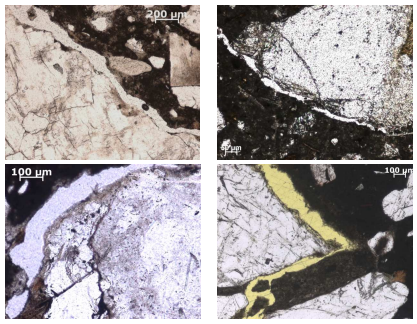
- Microscopic examination – debonding

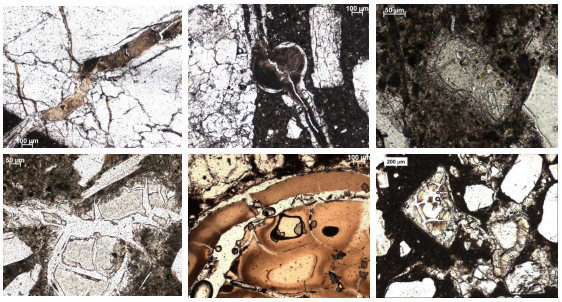
- Microscopic examination – alkali-silica gel

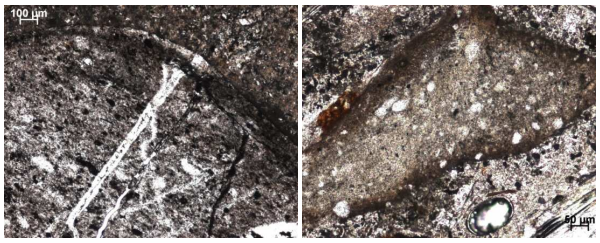
- Microscopic examination - rims

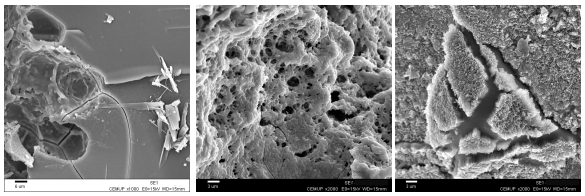
- Microscopic examination by SEM/EDS (exudations)

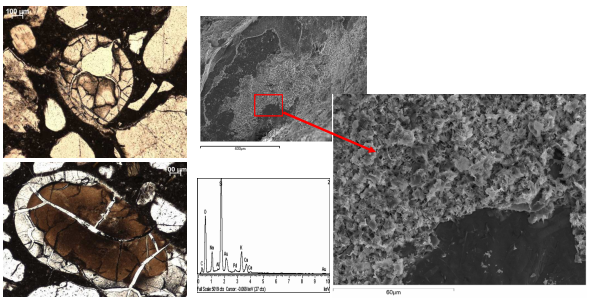
- Examples of application – Fagilde Dam
  - ✓ Manifestations of internal reactions
    - ➢ Gel in cracks and in siliceous particles of sand fraction

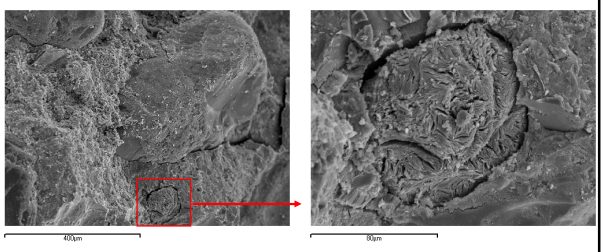
- Examples of application – Fagilde Dam
  - ✓ Manifestations of internal reactions
    - ✓ Ettringite in cracks, voids and in cement paste
