**A RESEARCH ON MANUFACTURING DEFECTS
AND DECAY BY GLAZE LOSS IN HISTORICAL
PORTUGUESE AZULEJOS**

DEPARTAMENTO DE MATERIAIS
Núcleo de Materiais Pétreos e Cerâmicos
Núcleo de Materiais Metálicos

Lisboa • Janeiro de 2011

RELATÓRIO 24/2011 – NPC/NMM

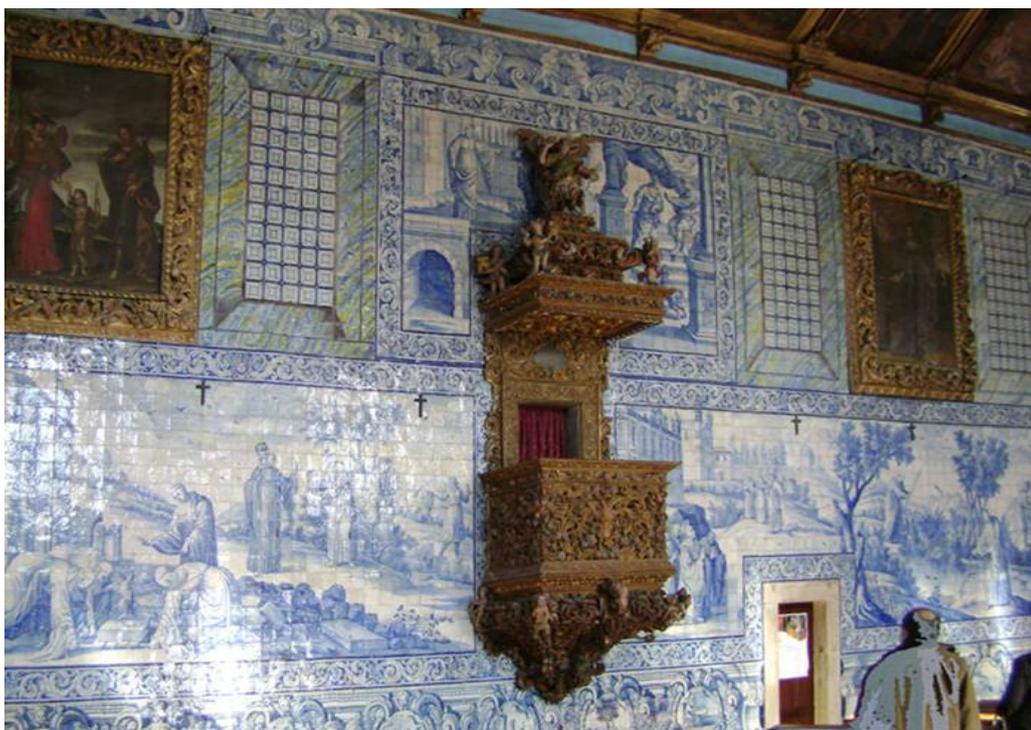
Figure 1 - Azulejos are a distinctive mark of Portuguese culture (Igreja do Terço, Barcelos)

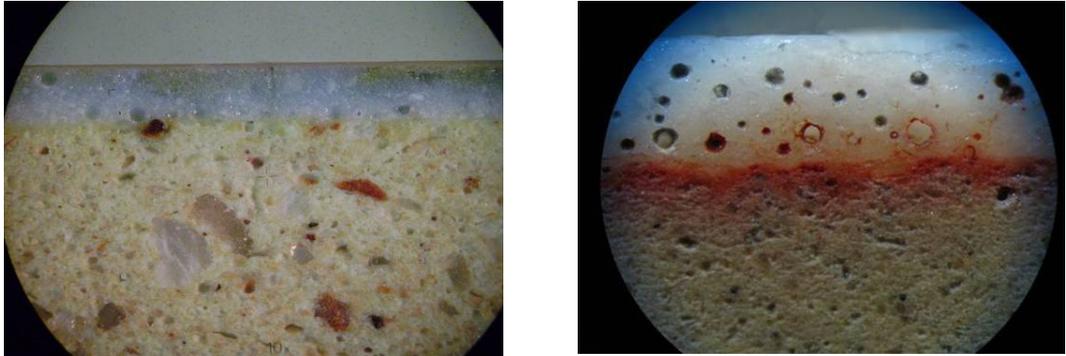
Tile defects were studied by OM using both a binocular microscope Meiji- EMZ-TR and a petrographic microscope Zeiss Axioplan MC-100. However, it must be borne in mind that very thin cracking is not always apparent. The biscuits of early Portuguese tiles are usually of a very light colour, so as to avoid impairing the whiteness of the majolica, and thus the exact boundary between glaze and biscuit may be difficult to pinpoint by OM while the true extension and path of thin cracks is not easily disclosed (figure 4a) particularly when they propagate horizontally in the glaze-biscuit interface.

the biscuit has zones of spongy porosity that readily absorb ink without actually having any cracks (Figure 4b).

Figure 4a- Cracking systems are often confusing with optical imaging (a crack runs vertically with an almost invisible side branch under the glaze)...
... and (Figure 4b) inking may be misleading – lots of colour but no cracks here

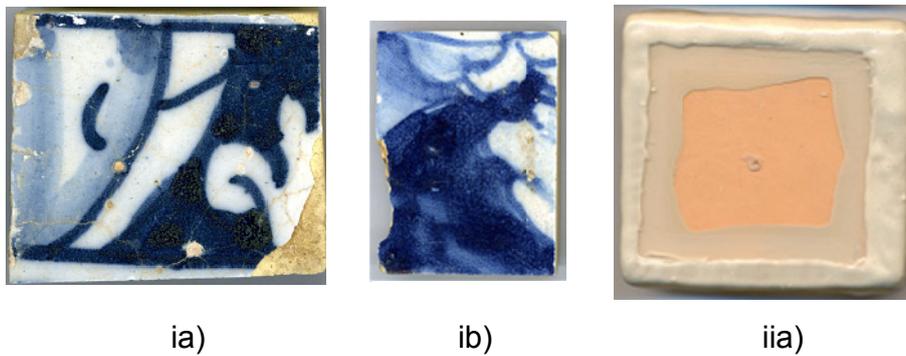
that simulated defectuous glazed tiles. Figure 6 illustrates some of the samples. The test protocol was very simple: the lateral surfaces of all samples were made water-tight with epoxy resin and the sample fully wetted with a 3:10 wt/wt solution of sodium chloride. After wetting, the back side of the samples was isolated with plastic film glued with mastik so as to force evaporation through the glaze side. Type I samples were then let dry for as long as it took in a ventilated oven at 60°C. After drying, any new damage was noted and the cycle repeated. The wetting cycles after the second were done with deionised water. Type II samples were subject to just one drying cycle at 40°C after imbibition in the saline solution.

Figure 6- A selection of Types I and II samples for study through artificial ageing tests by salts crystallization.

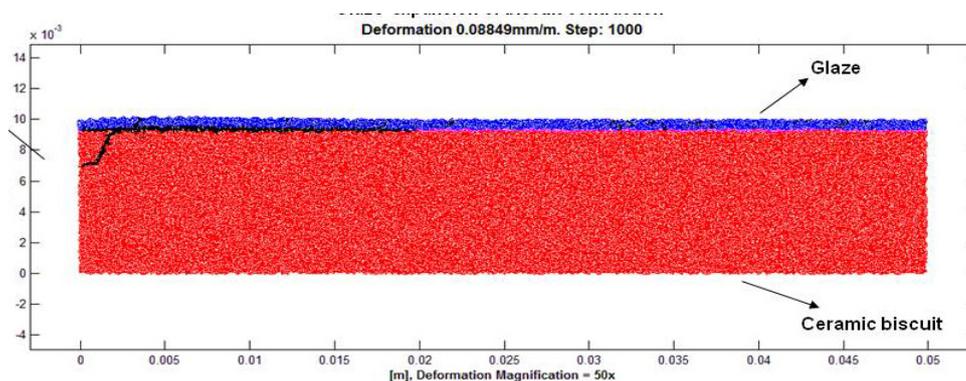
A less known but potentially more noxious manufacturing defect than crazing is *shivering*, which stems from the opposite situation: the thermal expansion coefficient of the glaze is not tuned to that of the biscuit in a way that during the cooling phase, after the second firing, the ceramic body contracts considerably more than the glaze. Due to the resulting compression tensions, the glaze may suffer small nicks on the edges or detach from the biscuit (*glaze delamination*). The results of a numerical simulation done as mentioned in Chapter 3 [4] has shown that, due to the arising stresses, in a flat tile the damage starts near the edges where the glaze may separate locally from the body and break, cause a sloping cracking of the biscuit or, indeed, even propagate to the centre of the tile resulting in extensive detachment patches (figure 14). In irregularly surfaced tiles, the glaze will tend to form a chord of any arch and thus conceivably delaminate locally anywhere in the glaze area. The lower the adhesion between glaze and biscuit, the less the degree of thermal retraction incompatibility needed to result in delamination by shivering.

Figure 14- One step of the graphic result of a numerical model of a propagating glaze delamination (black fracture crack) in a cooling tile subject to shivering (numerical model by Miguel Abreu, image taken from [4])

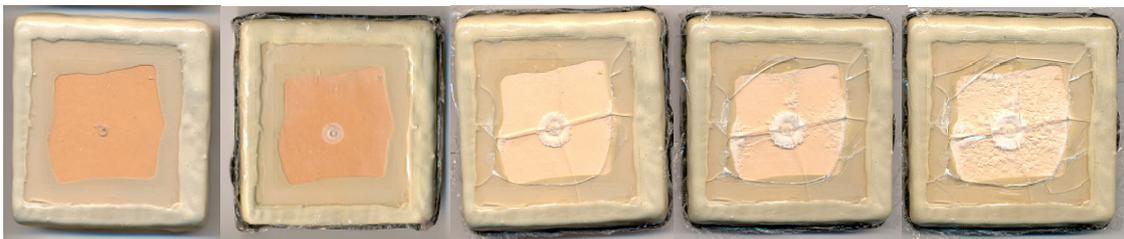
Shivering is an insidious manufacturing defect that, given the proper conditions, may lead to extensive glaze losses in a relatively short lapse of time and so this case, quite common but, to our knowledge, misunderstood and as yet undescribed in scientific literature until now as a source of decay of azulejos, has been of considerable interest to us. We simulated this phenomenon in the laboratory through accelerated ageing tests with salt solutions, both on the naturally delaminated tile shown in figure 18a and in simulated tiles made from thin sheets of glass with pin-holes across that were glued on their periphery to ceramic bodies (as described in chapter 2.3 and shown in figure 6). On both cases the bubbling behaviour was observed, eventually leading to the loss of

Figure 22- Evolution until breakage of a simulated glaze delamination with a through pore, during time, while drying at 40°C after one imbibition with a sodium chloride solution.

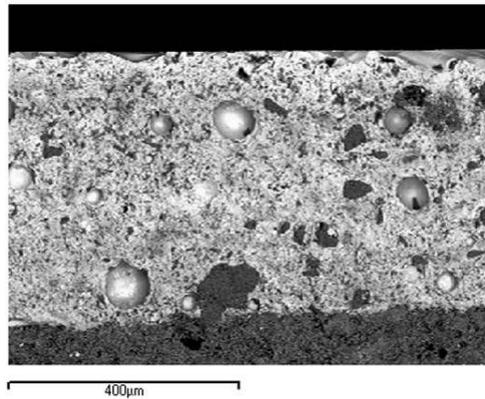
It is well known that any section in the glaze of an azulejo shows a large density of bubbles of all sizes, some of which may eventually occupy most of the glaze width. Figure 23 was obtained in a non-impregnated and barely polished sample, for illustrative purposes only. The likeness to spheres is misleading because actually the sectioned bubbles are only empty caps.

Figure 23- Glaze bubbles in an azulejo (BSE)
