Inglesinhos convent: Compatible renders and other measures to mitigate water capillary rising problems

Journal of Building Appraisal (2009) 5, 171–185. doi:10.1057/jba.2009.28

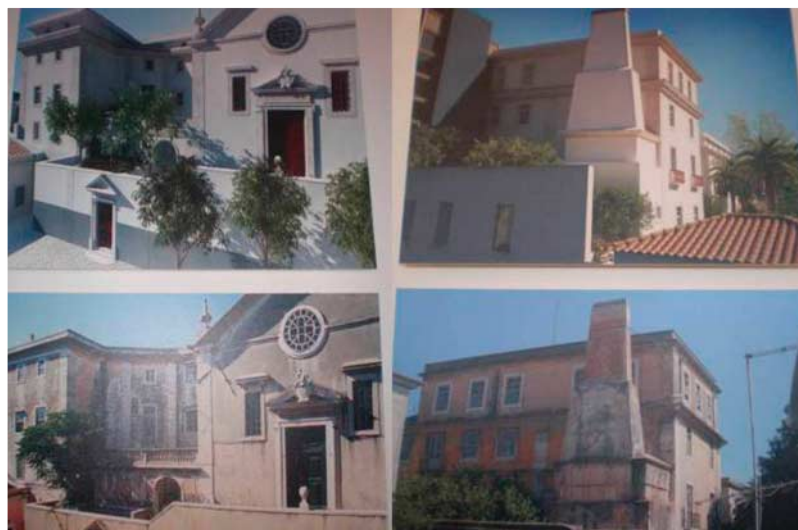
Figure 1: Inglesinhos convent: views before and after the intervention.

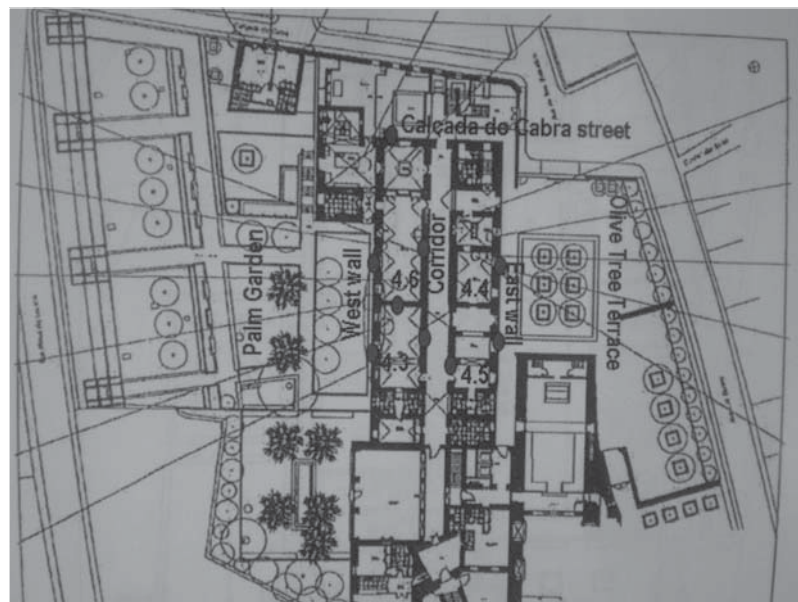
Figure 7: Plan of the ground floor with the tests localization.

The tests were carried out in several internal and external walls, whose localization is illustrated in Figures 7 and 8, for the ground floor and the first floor, respectively.
