Presentation to Trans-national Workshop
NRA: Maintenance and repair of bridges

Albert Daly
National Roads Authority, IRELAND

Ferrycarrig Bridge, Wexford, IRELAND

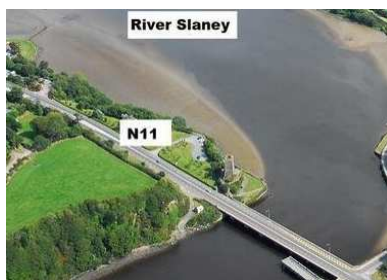
- Prestressed concrete beam-and-slab bridge
- Located in the South-west corner of Ireland, marine environment
- Offered to DuratiNET Activity 7 (Performance evaluation of repair systems and products) as a case study

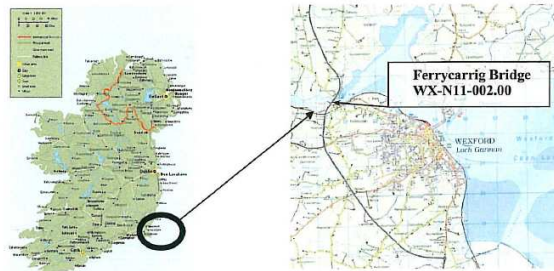
Ferrycarrig Bridge, Wexford, IRELAND

- Constructed 1980
- Length 125.6m, 8 equal spans (15.7m)
- Carried N11 single carriageway road over river Slaney estuary
- Precast, prestressed concrete beam-and-slab bridge
- Reinforced concrete piers and cross-heads
- Continuous except centre pier where there an expansion joint
- Integral with abutments
- Piers consist of two separate walls encasing steel tubular piles

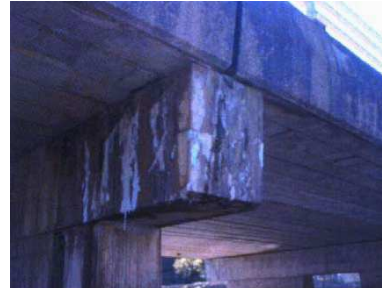
Ferrycarrig Bridge, Wexford, IRELAND

History of the structure:

- Principle Inspection carried out in 2002 using EIRSPAN procedures
- All components visually examined
- Structure in fair condition

Except for...

- Extensive cracking found in cross-heads and south abutment
- Crack widths up to 3.5mm
- Larger cracks at exposed end of cross-heads
- Cracking not attributed to any specific structural mechanism
