d	uratiNet	5 <sup>th</sup> Transnational Workshop UV, VIGO, 21 <sup>st</sup> January 2011	Consultoria Técnica
		Initial assessment	
		Preliminary visual inspection	
$\succ$	Identification of the main	deterioration mechanism	
		- Stress Corrosion Cracking sses which may also be taking place	
$\succ$	Mapping of damages		
$\checkmark$	Preliminary selection of s	sites for subsequent testing	
	dur	atiNe	;t
	European Utrion December Regioner December Regioner	ure ATLANTIC AREA Transational Programme

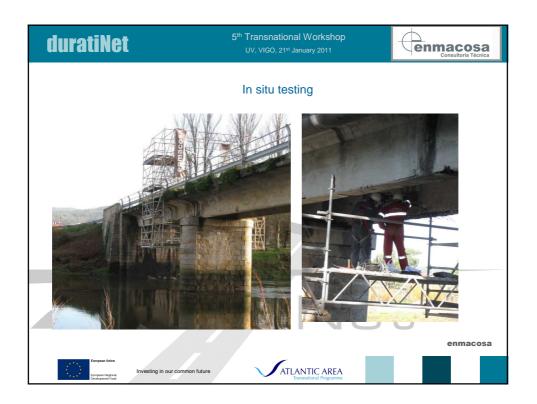
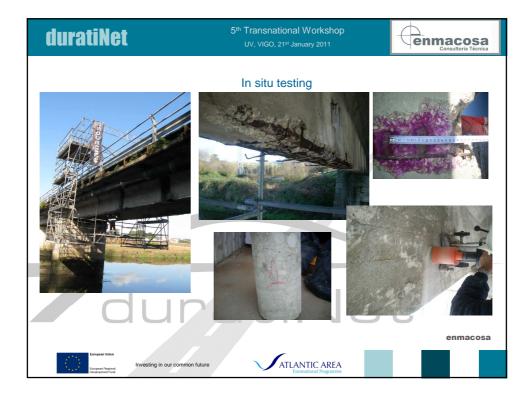
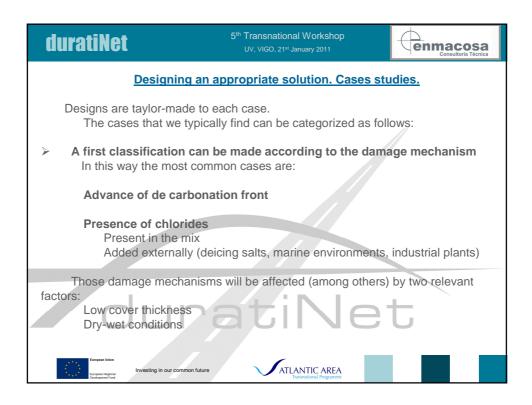
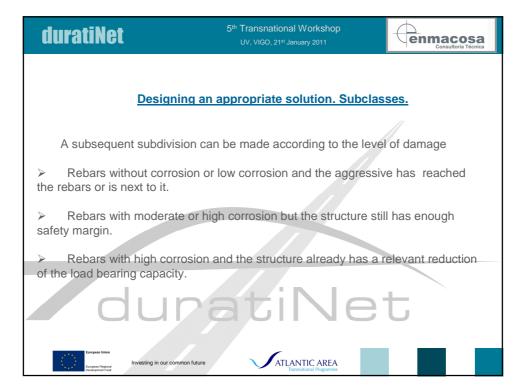
duratiNet	5 <sup>th</sup> Transnational Workshop UV, VIGO, 21 <sup>st</sup> January 2011	enmacosa Consultoria Técnica		
In situ testing				
Depth of aggressive front: carbonation and chloride advance				
	Mechanical strength			
	Resistivity			
Geometry and dimension of element				
	Cover thickness			
Section loss				
Rebar detailing				
Emperature Exemption Region Exemption France	re ATLANTIC AREA Transational Programme

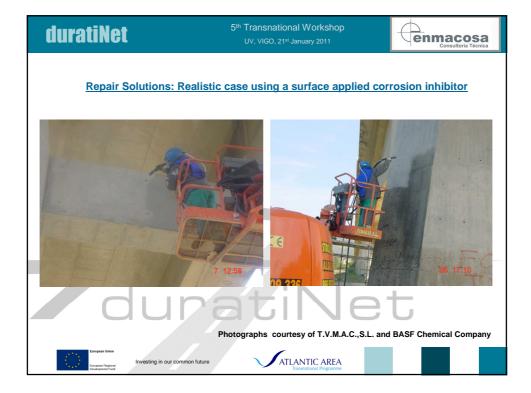
duratiNet	5 <sup>th</sup> Transnational Workshop UV, VIGO, 21 <sup>st</sup> January 2011	Consultoria Técnica			
Repair Solutions for each case.					
Next we expose different solut	ions for usually cases of damage mechanism	n and level of damage			
	Case 1				
	Damage mechanism: Advance of de carbonation front, chlorides, or both simultaneously. Level of damage: Rebars without corrosion or low corrosion and the aggressive has reached the rebars or is next to it.				
	Repair process				
	<ol> <li>The cover thickness and the concrete in contact with the steel must be passived. In order to achieve this effect we prescribe a surface applied corrosion inhibitor, for use as an impregnation of steel reinforced concrete.</li> </ol>				
FerroGard-903. Protectosil Cit					
<ol> <li>Both products can be used as part of an overall repair strategy using concrete Repair Systems to increase the cover thickness and provide additional corrosion protection.</li> </ol>

MonoTop-620 EMACO NANOCRETE R4					
There are several commercial products but to carry on a guarantied repair we always recommend integrated systems and contrasted manufactures.					
European Union Brownen Regioner Brownen Press	on future ATLANTIC AREA Transactional Programme

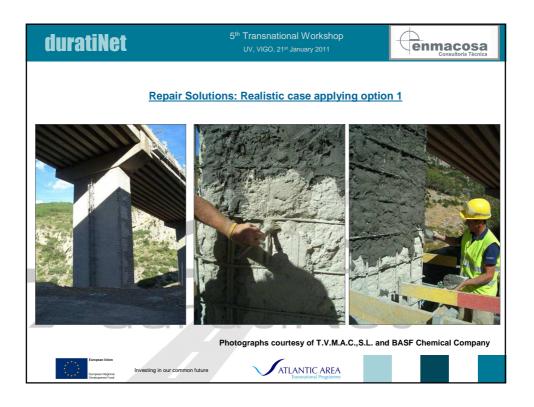
duratiNet	5 <sup>th</sup> Transnational Workshop UV, VIGO, 21 <sup>st</sup> January 2011	enmacosa Consultoria Técnica		
Repair Solutions for each case.				
<u>Case 2</u> Damage mechanism: Advance of de carbonation front, chlorides, or both simultaneously. Level of damage: Rebars with <b>moderate or high corrosion</b> and the structure still has enough safety margin.				
Integrated commercial systems.				
To carry out a guarantied repair we always recommend to apply contrasted and integrated systems.				
Option 1:				
Emaco NanoCrete AP Functions: rust inhibiting properties as it reinstates a high pH environment				
Emaco NanoCrete R4 Functions: structural concrete repair and reprofiling				
Masterseal 325E Functions: final protective coat , water repellent, used for control of moisture and Chloride ion ingress, CO2 and SO2.				
European Union Designent Regional Designent Fload	non future ATLANTIC AREA Transational Programme
